MIL-HDBK-138B  
1 JANUARY 2002

# DEPARTMENT OF DEFENSE HANDBOOK

## GUIDE TO CONTAINER INSPECTION FOR COMMERCIAL AND MILITARY INTERMODAL CONTAINERS

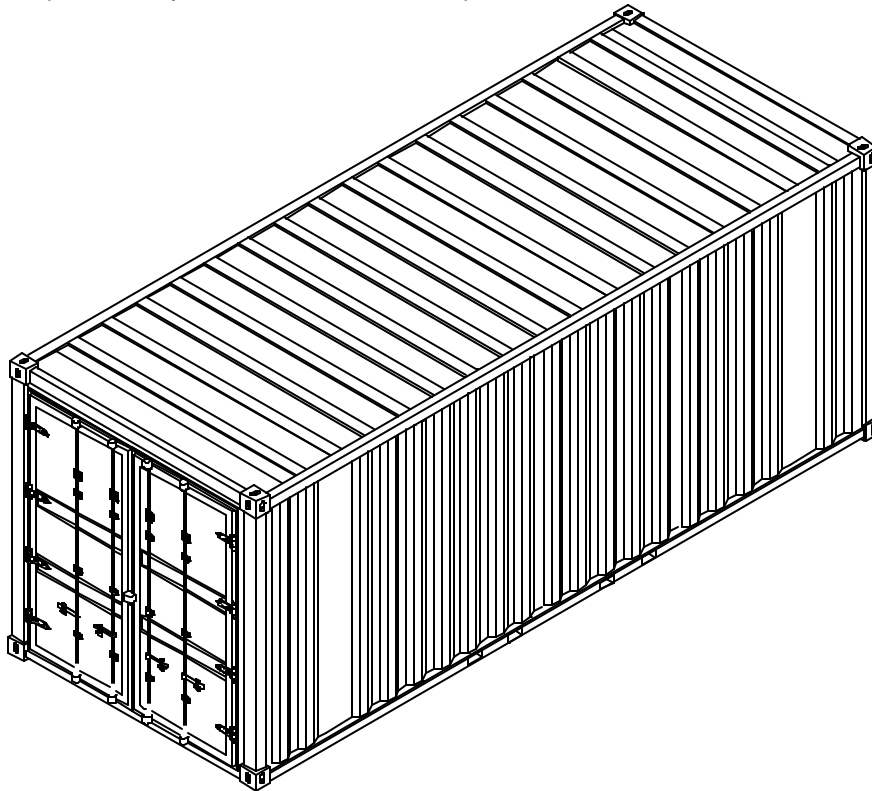
3.1 Typical End-Opening Steel Container. Refer to Figure 3.1. The most common type of freight container is the general purpose dry cargo type. This container completely encloses its contents by permanent steel structures and provides cargo loading access through end opening doors.

The flooring may be soft or hard laminated woods, planking, plywood, or composition material either screwed or bolted to the floor cross members. The floor cross members may be box, C, Z, or I shaped steel beams bolted or welded to the bottom side rails. Some containers are configured with an all-steel flooring or a combination of wood and steel.

An intermodal freight container is primarily handled via connection with its internationally standard corner fittings; however, many steel containers are also provided with empty and/or loaded capacity forklift pockets to improve container handling versatility. Performance specifications for a typical end-opening steel container are provided by commercial item description A-A-52032.

FIGURE 3.1 TYPICAL END-OPENING STEEL CONTAINER

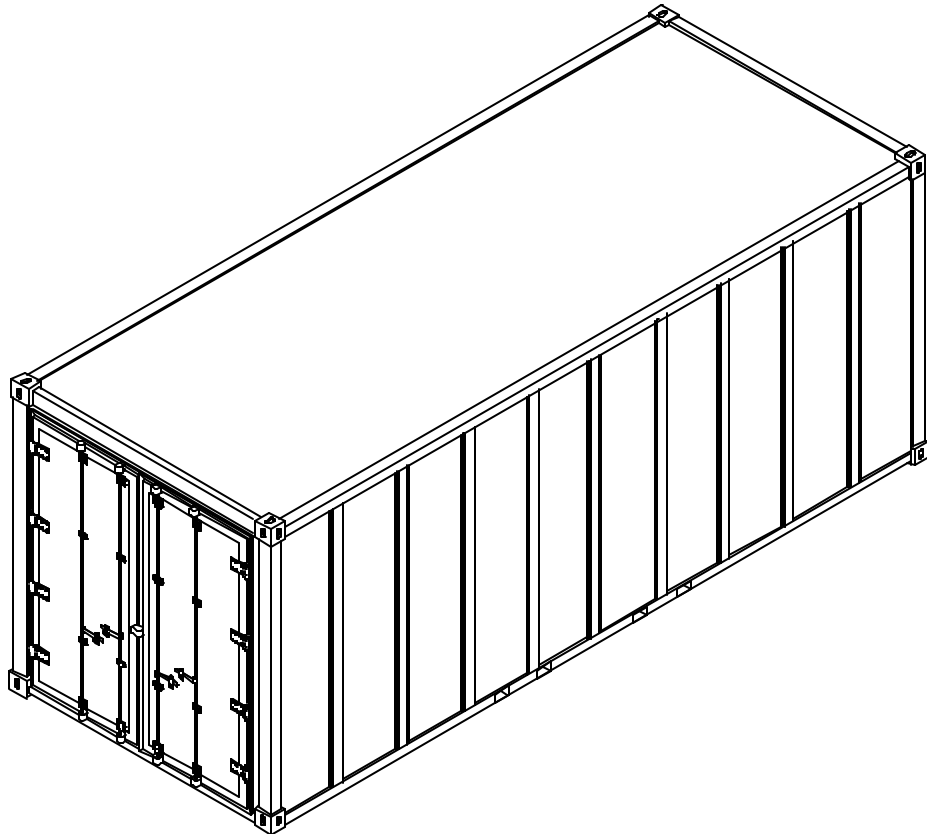
3.2 Typical End-Opening Aluminum Container. Refer to Figure 3.2. A typical end-opening aluminum container, often referred to as aluminum/steel container, usually has steel end frames and structural steel or extruded aluminum side rails.

The flooring may be soft or hard laminated woods, planking, or plywood either screwed or bolted to the floor cross members. The floor cross members may be box, C, Z, or I shaped beams of either steel or aluminum that are bolted, riveted, or welded to the bottom side rails.

The nominal dimensions and many construction details are otherwise similar to those of steel end-opening containers.

FIGURE 3.2 TYPICAL END-OPEN ALUMINUM CONTAINER

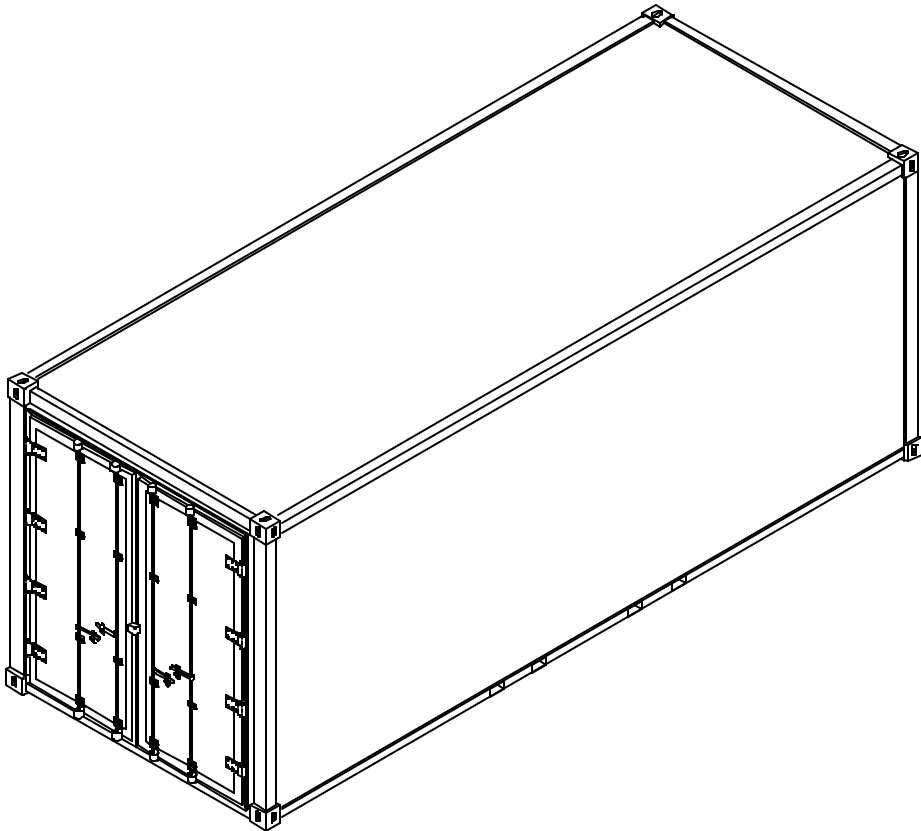
3.3 Typical End-Opening FRP Container. Refer to Figure 3.3. A typical end-opening Fiberglass Reinforced Plywood (FRP) container is usually constructed of structural steel framing; fitted with standard corner fittings (steel castings) at all eight corners; and has FRP panels on the side walls, front end wall, and roof.

The flooring may be soft or hard laminated woods, planking, or plywood either screwed or bolted to the cross members. The floor cross members may be box, C, Z, or I shaped beams.

The nominal dimensions and many construction details are otherwise similar to those of steel end-opening containers.

**FIGURE 3.3 TYPICAL END-OPENING FRP CONTAINER**

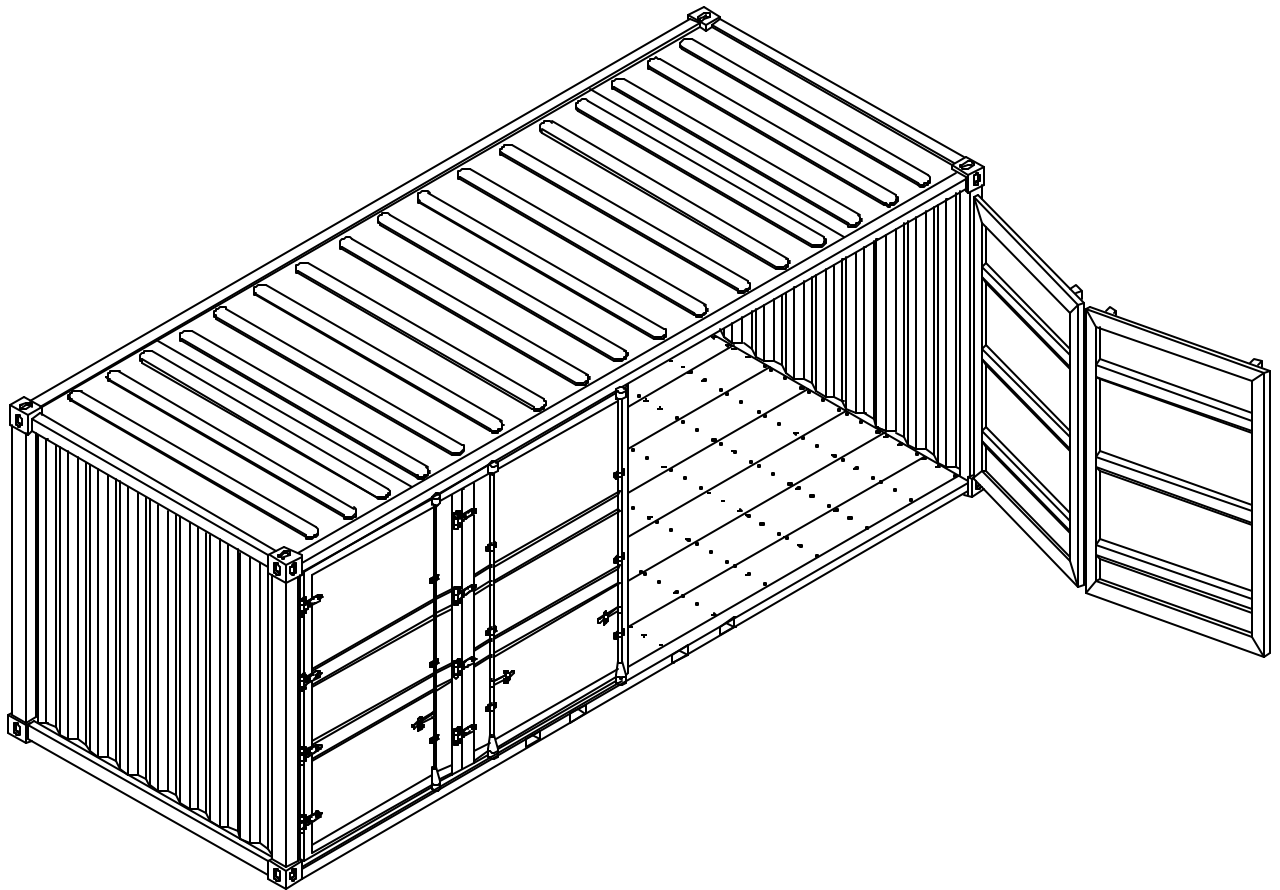
3.4 Typical Side-Opening Container. Refer to Figure 3.4. A side-opening container is similar in many respects to a typical steel end-opening container except there are doors on the side to provide access to the cargo space and the bottom side rails usually have a deeper profile. There may or may not be doors in the end frame of the container.

Performance specifications for a typical side-opening container are provided by commercial item description A-A-52029.

**FIGURE 3.4 TYPICAL SIDE-OPENING CONTAINER**

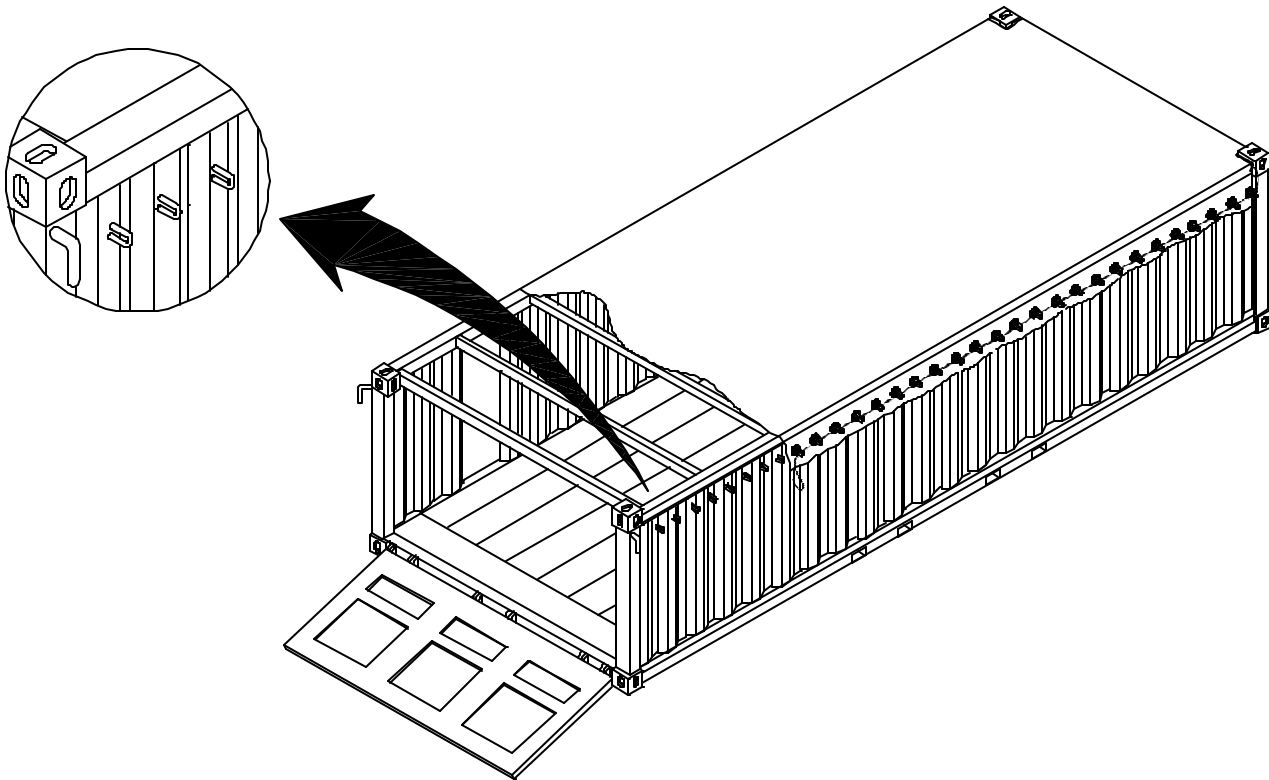
3.5 Typical Open-Top Container. Refer to Figures 3.5A and 3.5B. An open-top container is similar in all respects to a typical steel container except it has no rigid roof. Instead, it has a flexible or removable cover.

An open-top container may also have a movable or removable door header to facilitate access to the cargo. In some open-top containers, the end door opens downward to function as a loading ramp. Some open-top containers have all steel floors.

Three typical heights for open-top containers are 4 feet 3 inches high (half high), 5 feet 8 inches high (two-thirds high), and 8 feet 6 inches high (full high). Performance specifications for a typical half-high open-top container are provided by commercial item description A-A-52033.

**FIGURE 3.5A TYPICAL 1/2 HIGH OPEN-TOP**

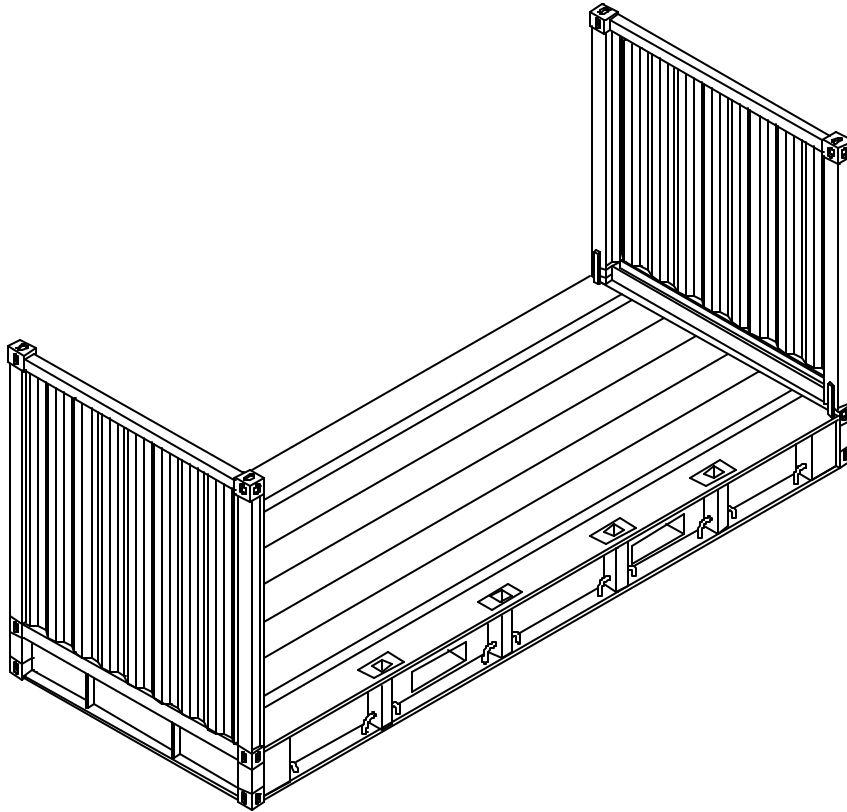
3.6 Typical Flatrack Container. Refer to Figure 3.6. The nominal dimensions and many construction details of a flatrack container are similar to those of a typical steel container except it does not have rigid side walls or a roof structure.

The flooring is usually either soft or hard wood planking that is specially treated and either screwed or bolted to the cross members. The planking may be intentionally configured with gaps between boards to allow drainage.

A flatrack container does not provide weather protection.

FIGURE 3.6 TYPICAL FLATRACK CONTAINER

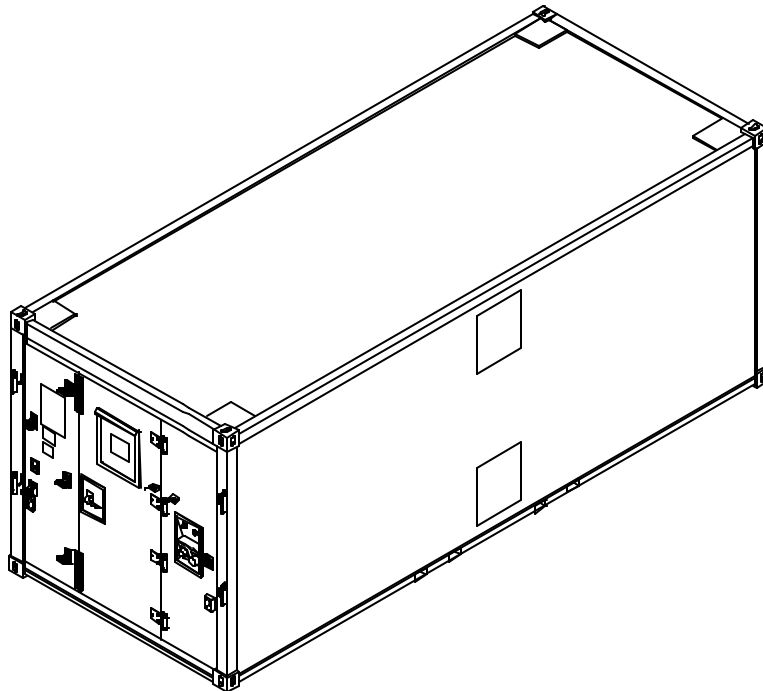
3.7.1 Army Tactical ISO Shelters. (Refer to Figure 3.7.1). The Army Tactical ISO Shelters are 8' high by 8' wide by 20' long structures, with a gross weight of up to 15,000 lbs. Although there are 6 different configurations of Army Tactical ISO Shelters, the basic structural design is the same. The shelters can either be non-expandable, 1-side expandable, or 2-side expandable.

**FIGURE 3.7.1 ARMY TACTICAL ISO SHELTER.**

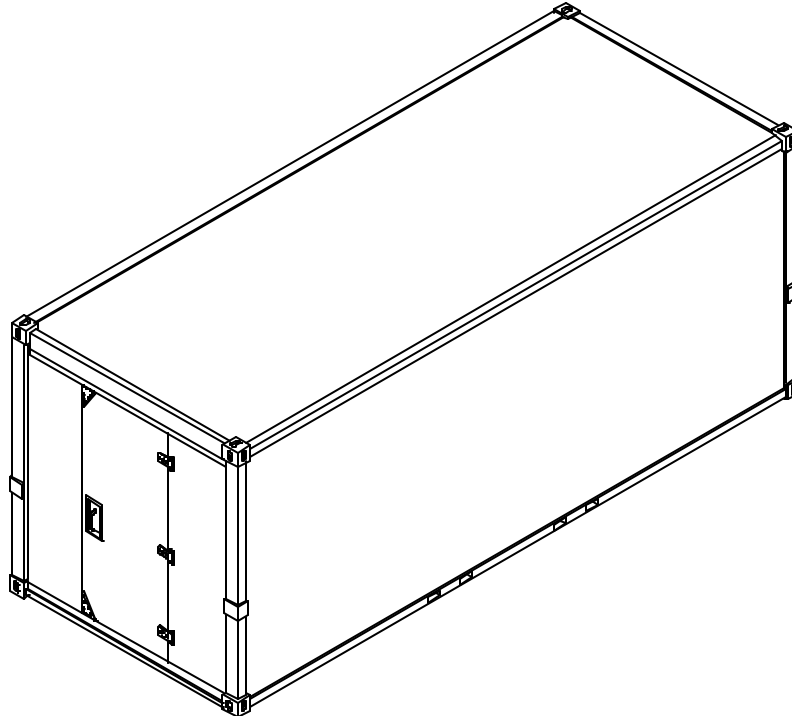
3.7.2 Marine Corps ISO Shelters (Refer to Figure 3.7.2). The Marine Corps ISO Shelters are 8' high by 8' wide by 10' and 20' long structures, with gross weight of up to 15,000 lbs. Although there are 5 different NSN items within this shelter family, the basic structural design of these shelters is the same. There are non-expandable 10' and 20' shelters and a 20' knock-down type.

**FIGURE 3.7.2 MARINE CORPS TACTICAL ISO SHELTER**

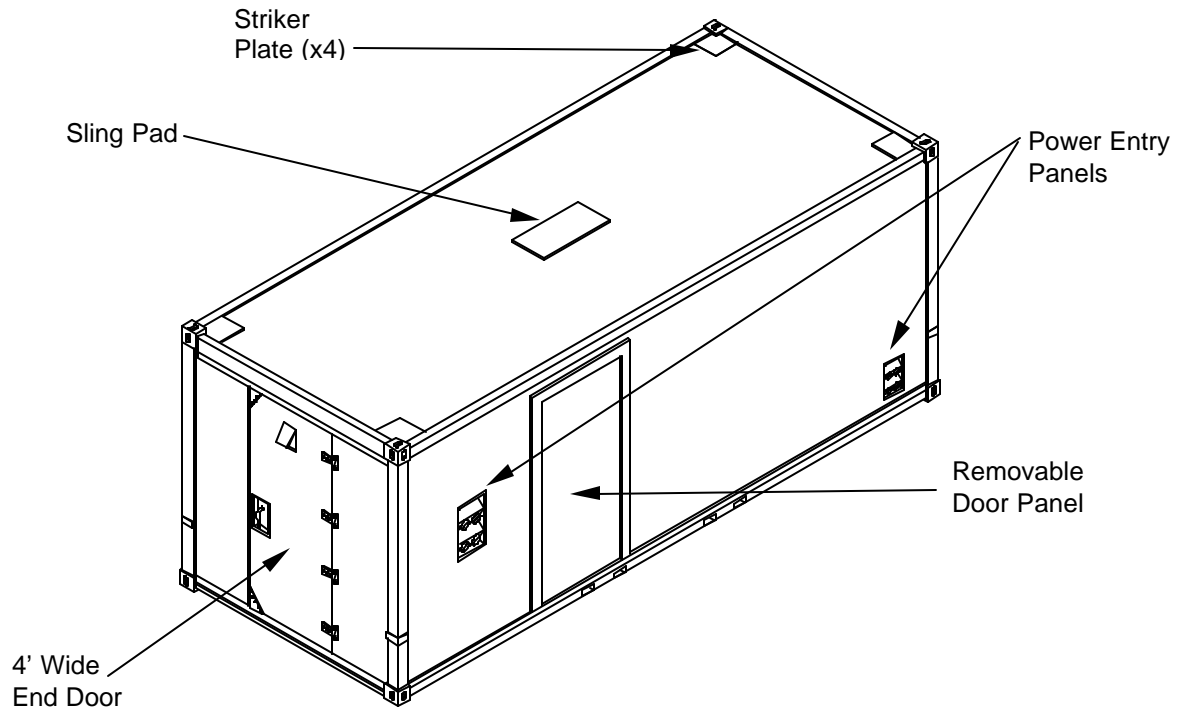
3.7.3 Navy ISO Shelters. Refer to Figure 3.7.3A and 3.7.3B. The Navy ISO Shelters are a family of 8' high by 8' wide by 20' long structures, with a gross weight of up to 20,000 lbs. Although there are 7 different NSN items within this shelter family, the basic structural design of these shelters is the same, and are all non-expandable 20'.

FIGURE 3.7.3A NAVY BMF ISO SHELTER

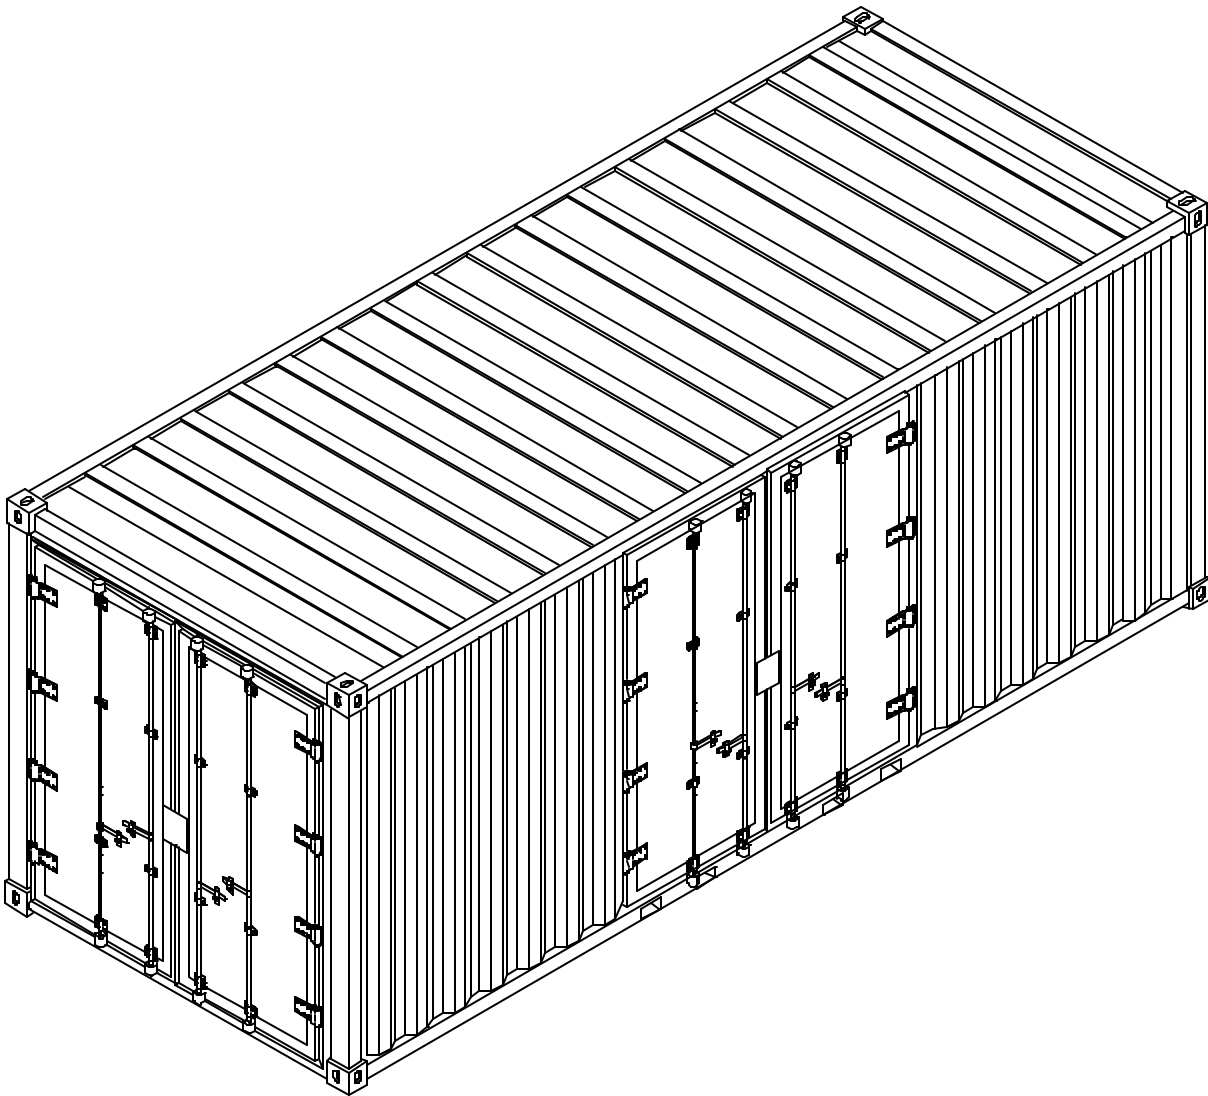
Length: 20' Width: 8' Height: 8'

Tare Weight: 5,150 lbs, 2,322 kg, Maximum Gross weight: 44,800 lbs, 20,320 kg

FIGURE 3.8 ARMY DEPMEDS CONTAINER

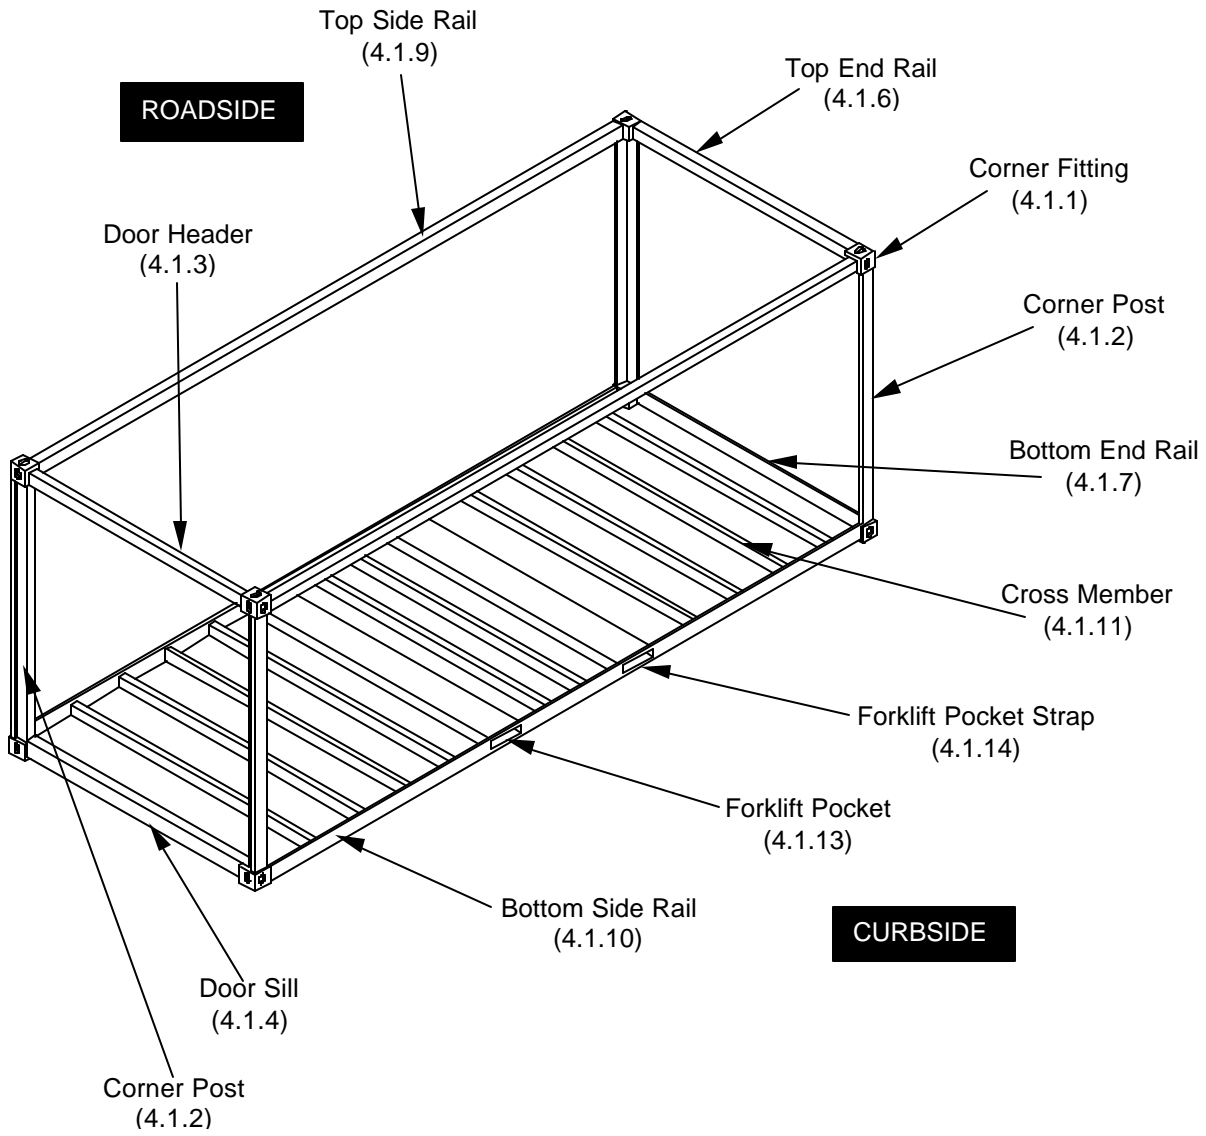
4.1 Primary Structural Components. Refer to Figure 4.1.

4.1.14 Forklift Pocket Strap. The plate welded to the bottom of each forklift pocket opening or part of bottom siderail. The forklift pocket strap is a component of the forklift pocket.

4.1.15 Gooseneck Tunnel. Recessed area in the forward portion of the understructure to accommodate transport by a gooseneck chassis. This feature is more common in forty foot and longer containers.

FIGURE 4.1 PRIMARY STRUCTURAL COMPONENTS

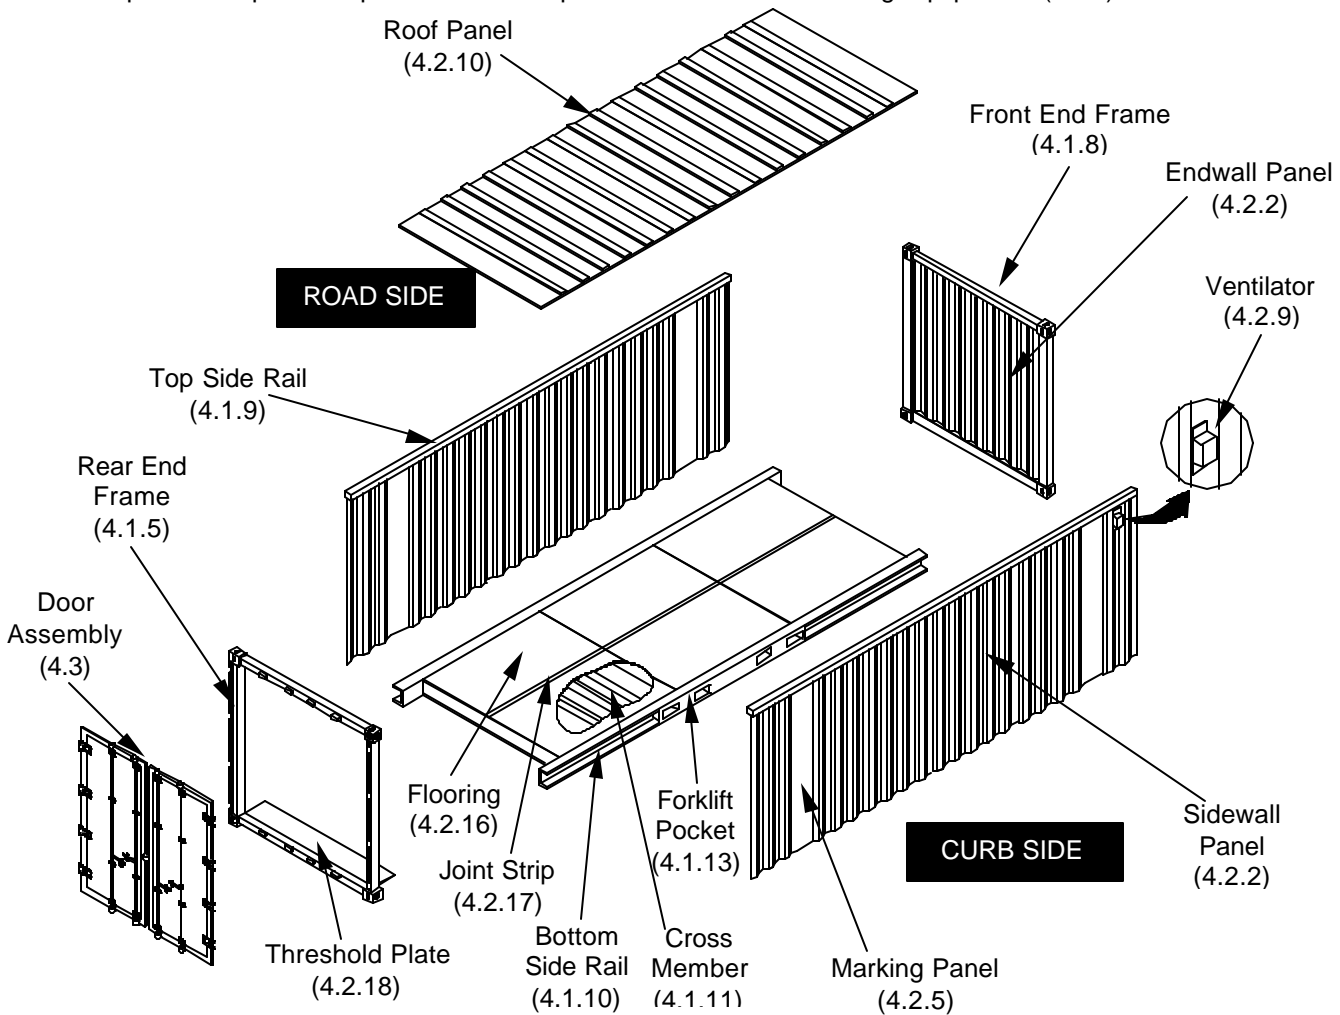
FIGURE 4.2A TYPICAL STEEL CONTAINER (EXPLODED VIEW)

4.2 Walls, Roof, and Floor. Refer to Figures 4.2A, 4.2B, 4.2C, 4.2D, 4.2E, 4.2F, 4.2G, and 4.2H.

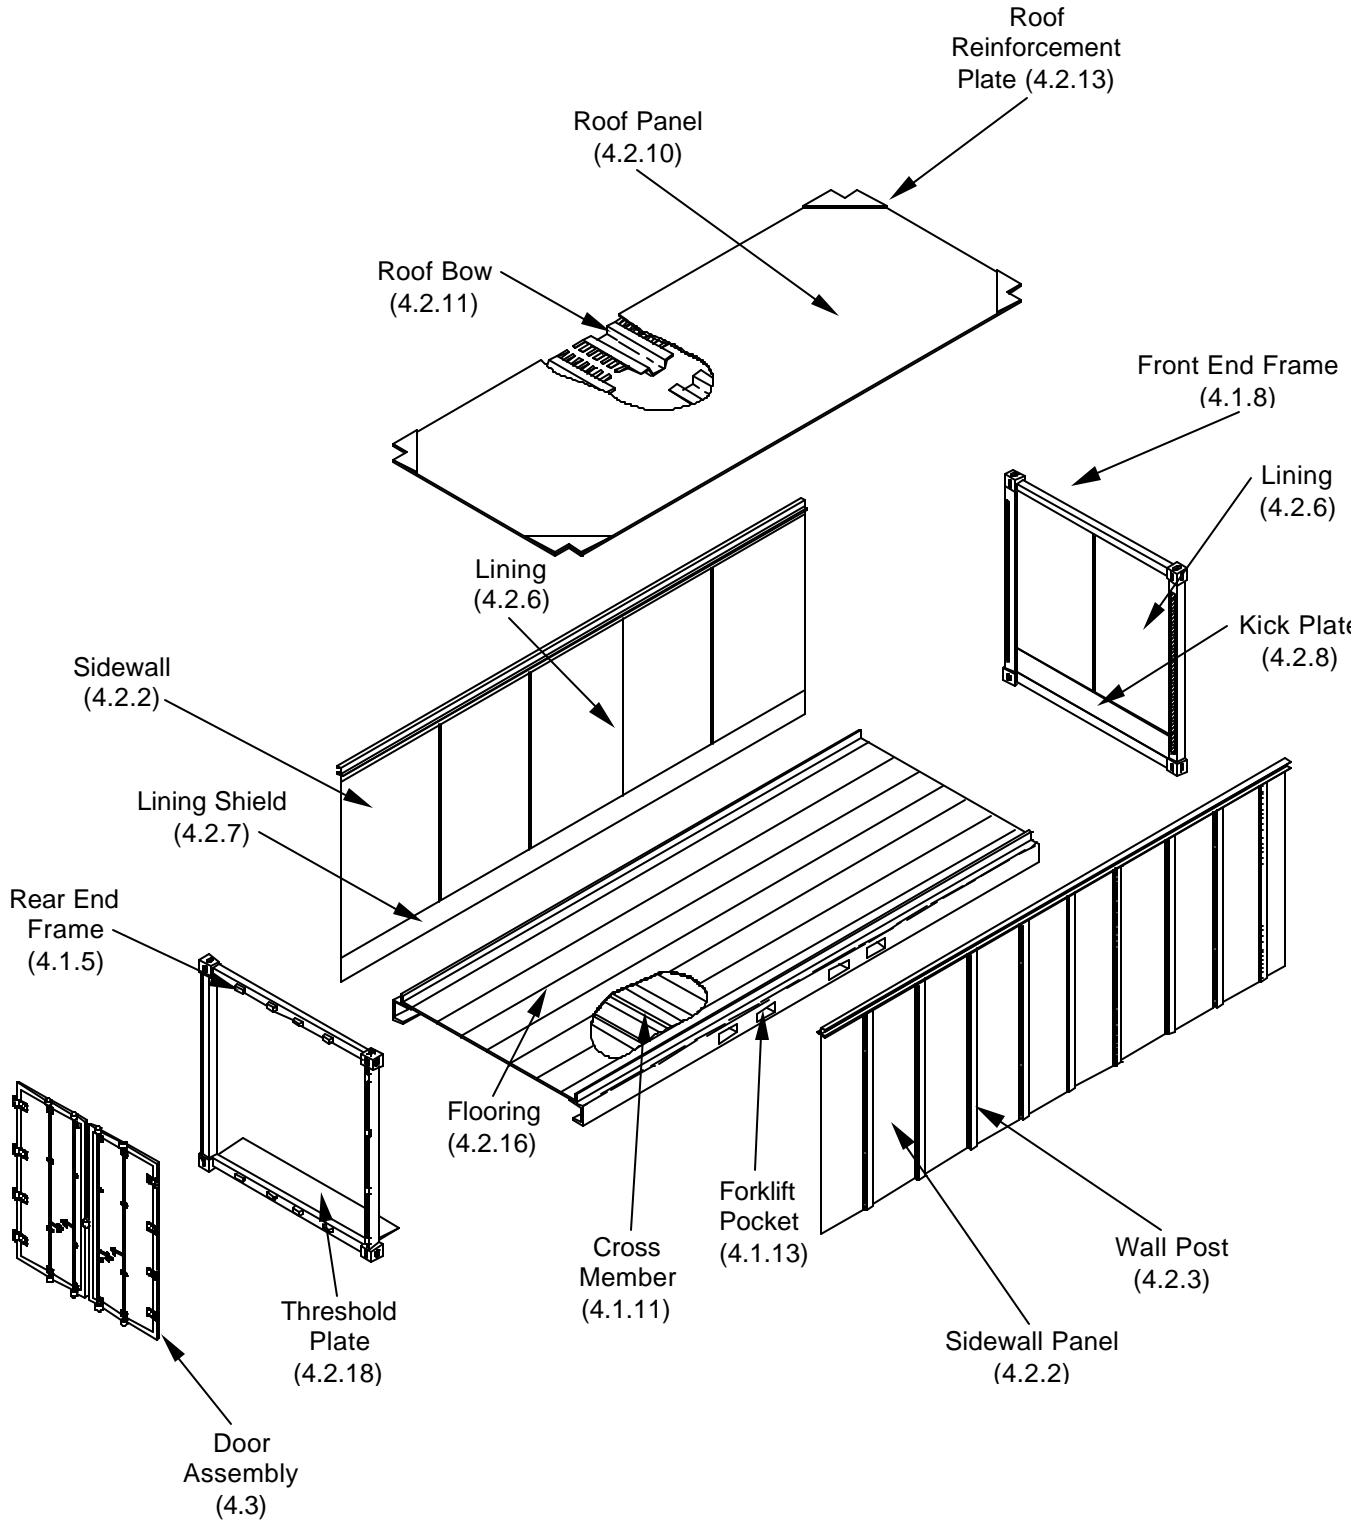
4.2.7 Lining Shield. A strip of thin metal installed at the bottom of the interior walls to protect the lower portion of the lining from damage by materials handling equipment during loading or unloading operations. (4.2B)

FIGURE 4.2B TYPICAL ALUMINUM CONTAINER (EXPLODED VIEW)

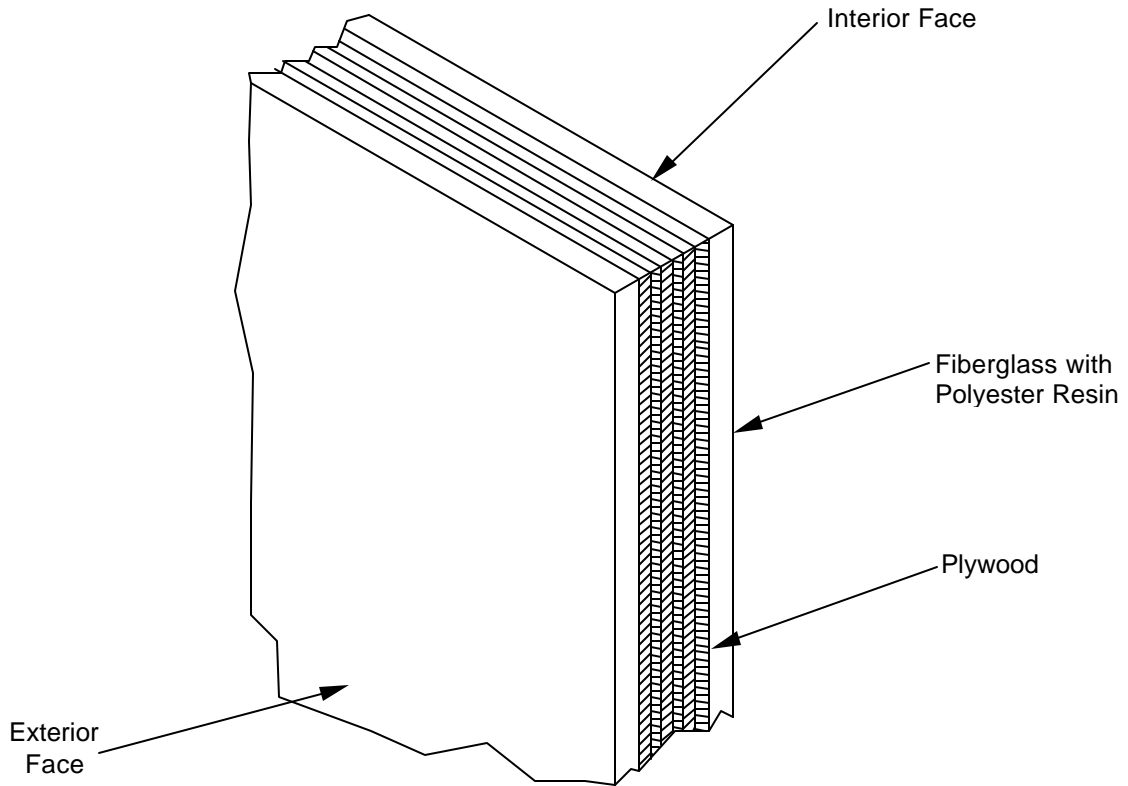
FIGURE 4.2C FIBERGLASS REINFORCED PLYWOOD (FRP)

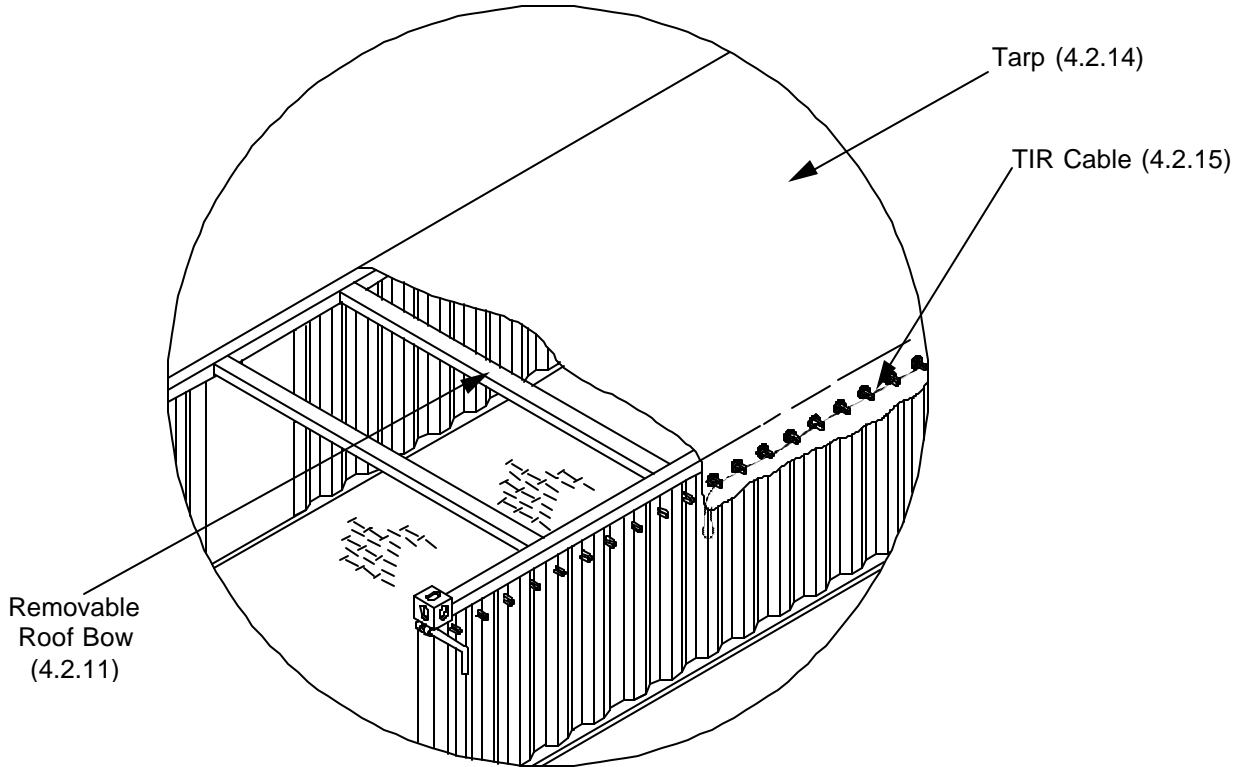
FIGURE 4.2D REMOVABLE COVER (TARP) ASSEMBLY

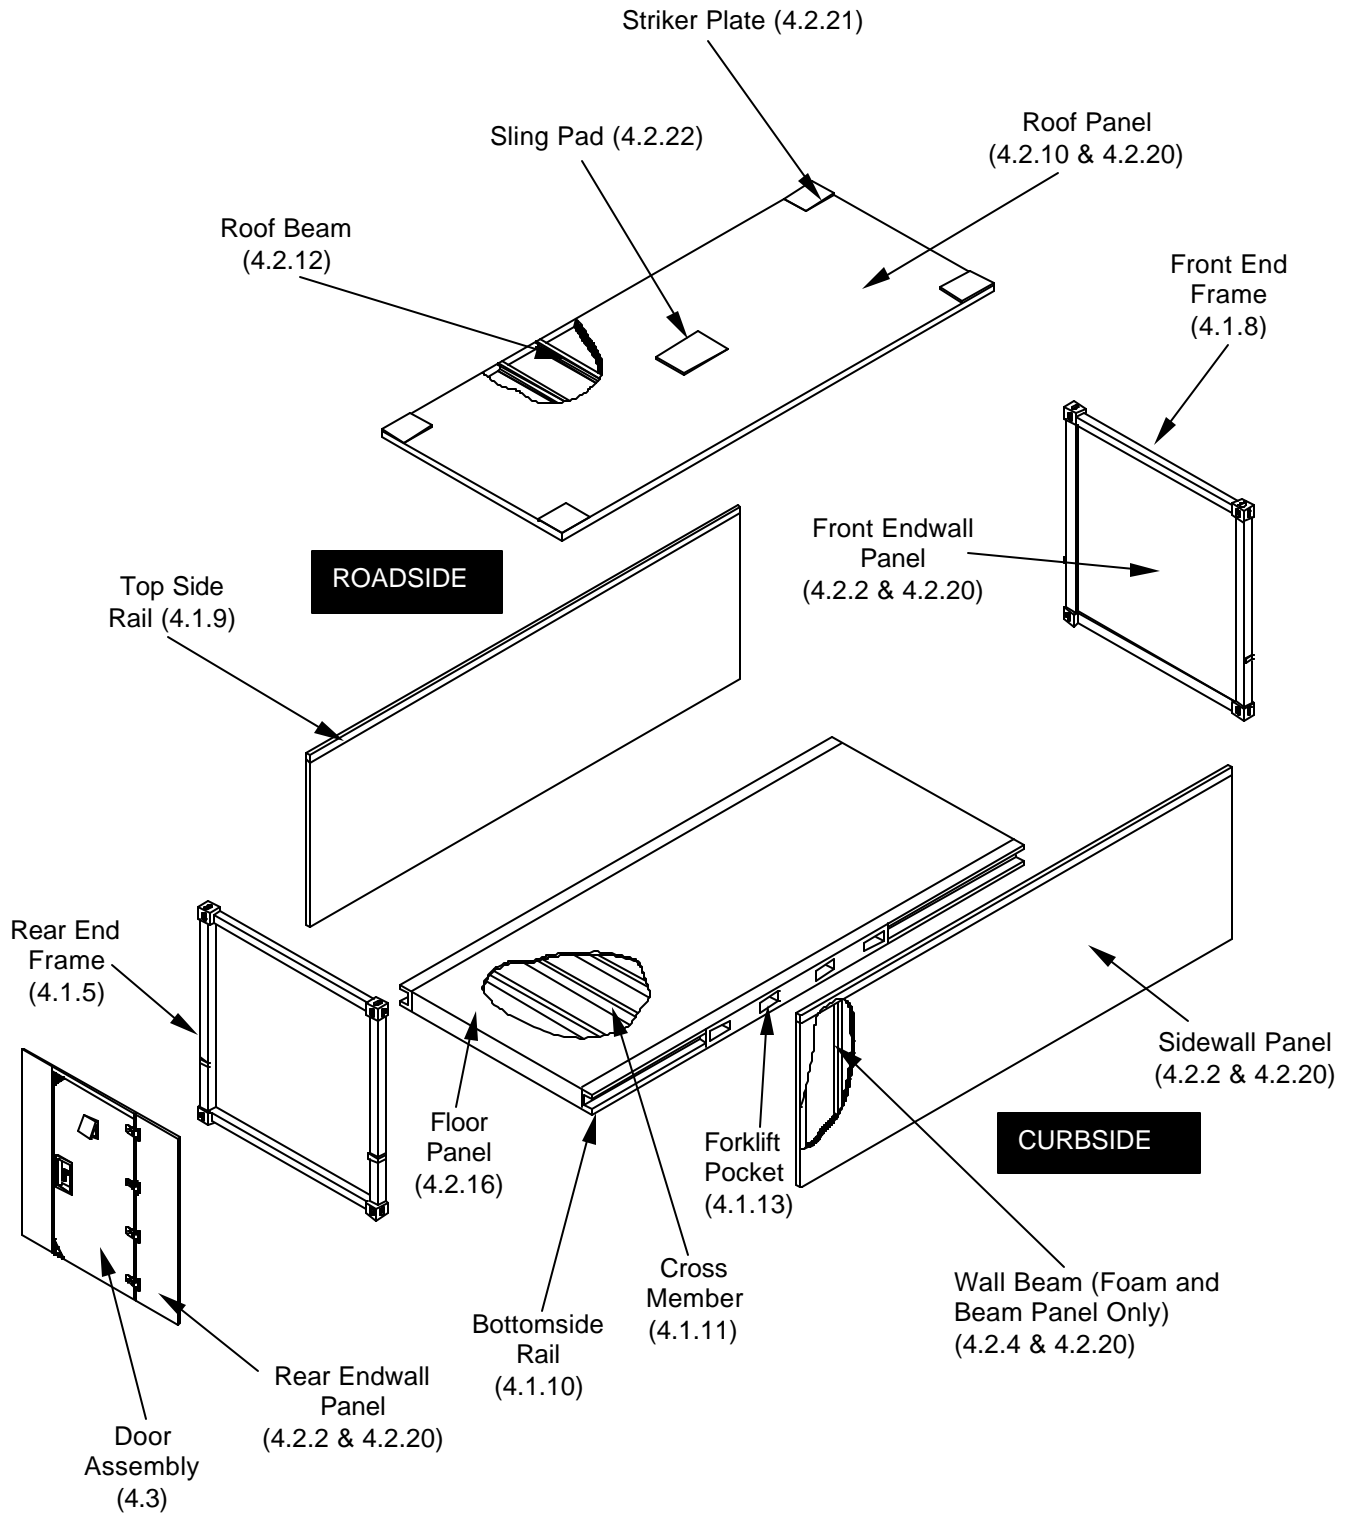
4.2.4 Wall Beam. Encapsulated vertical component to which sheet aluminum or steel is bonded to form a wall panel. This is found in foam and beam panels. (4.2E)

4.2.21 Striker Plate. An additional metal plate on the exterior of the roof panel adjacent to the top corner fittings that provides protection to the roof panel or top rail components from misaligned handling equipment. (4.2E)

4.2.22 Sling Pad. An additional metal plate on the exterior of the roof panel located in the center of the roof panel that provides protection to the panel from lowered handling equipment. (4.2E)

FIGURE 4.2E TYPICAL ISO SHELTER (EXPLODED VIEW)

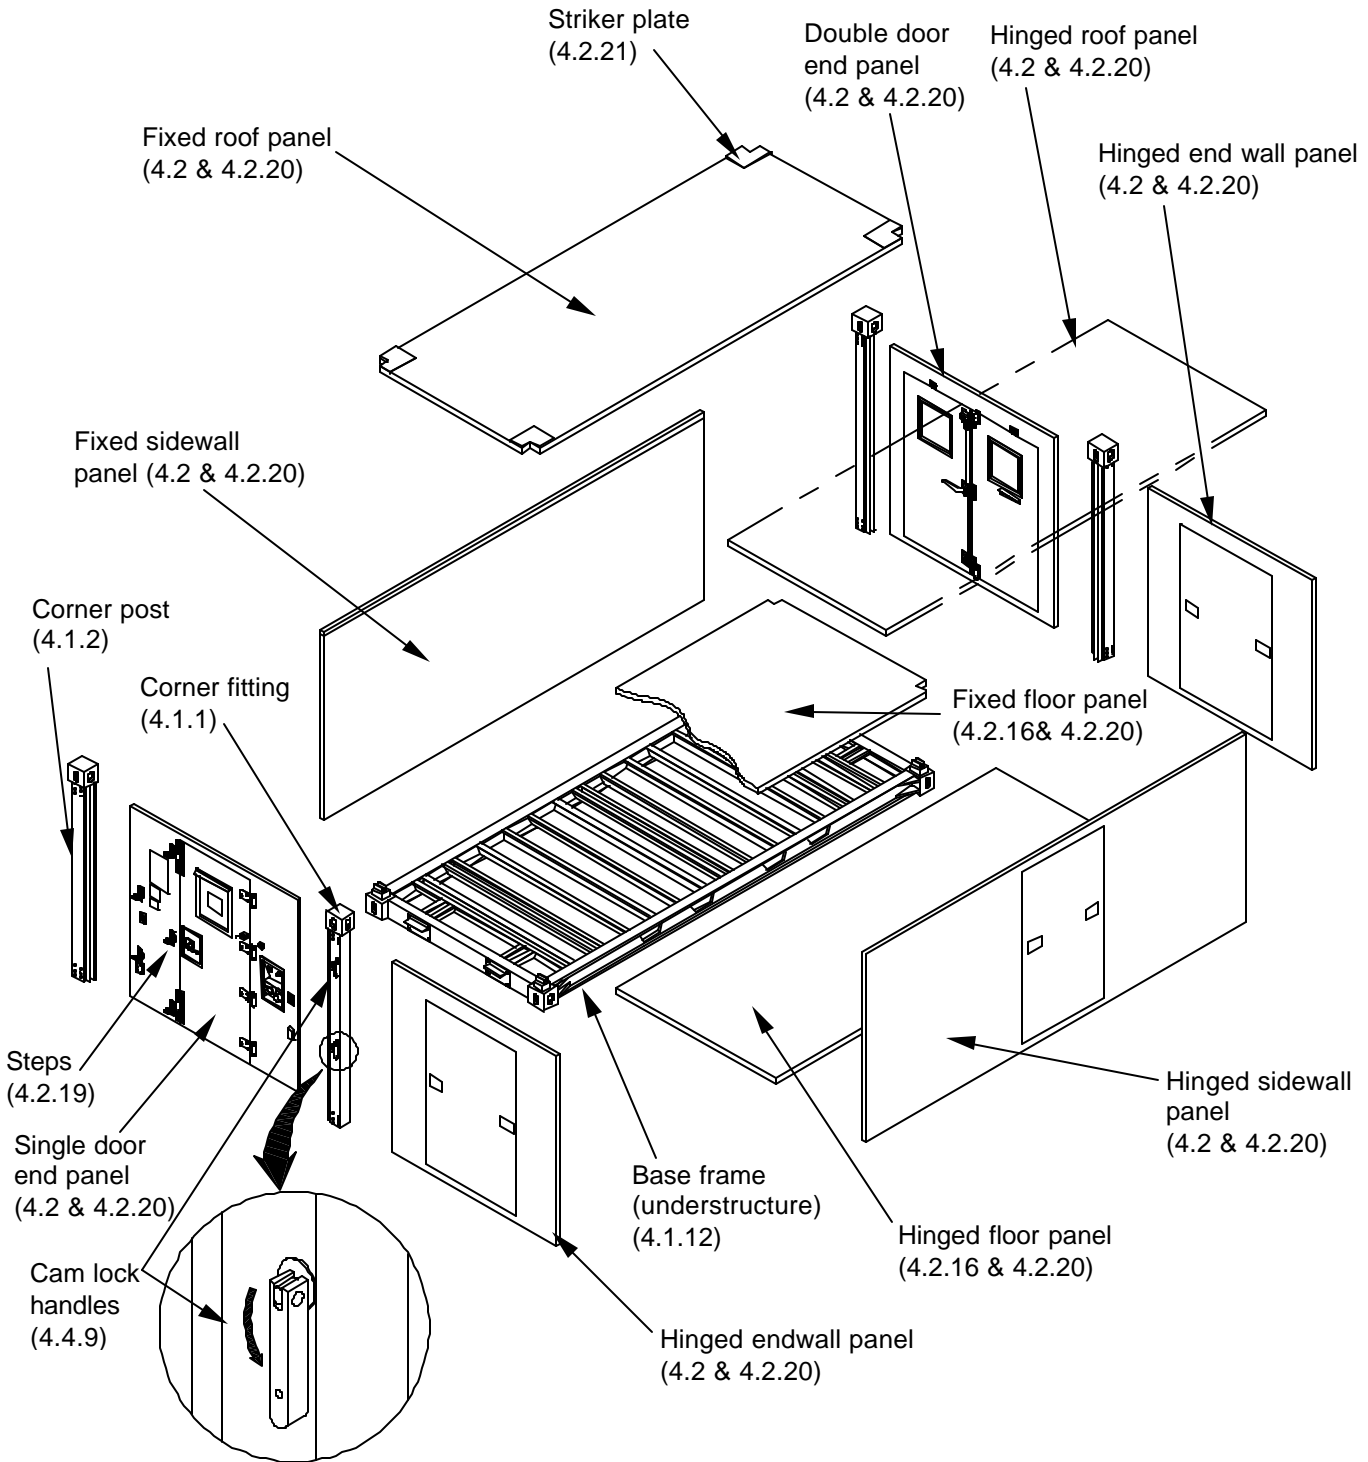
4.2.19 Steps. Folding steps are found on some ISO Shelters and are used to gain access to the roof. They must be folded up prior to transporting shelter. (4.2F)

FIGURE 4.2F TYPICAL ONE-SIDE EXPANDABLE ISO SHELTER (EXPLODED VIEW)

Hinged panels are those which will be enclosed inside the container during transport and storage.

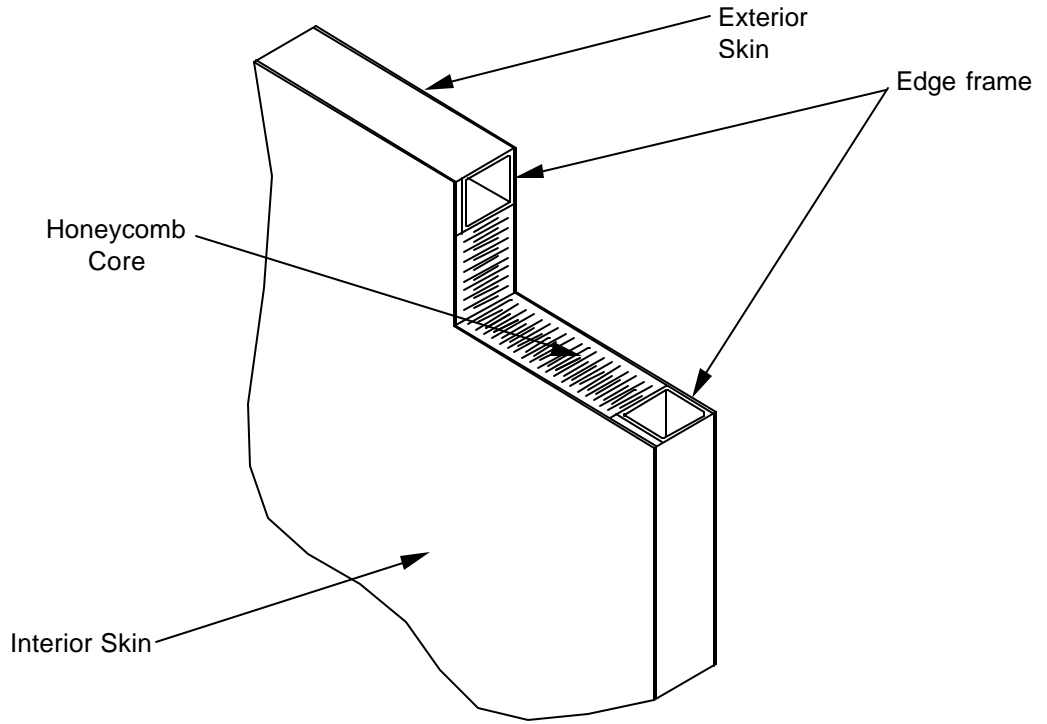
FIGURE 4.2G HONEYCOMB SANDWICH PANEL

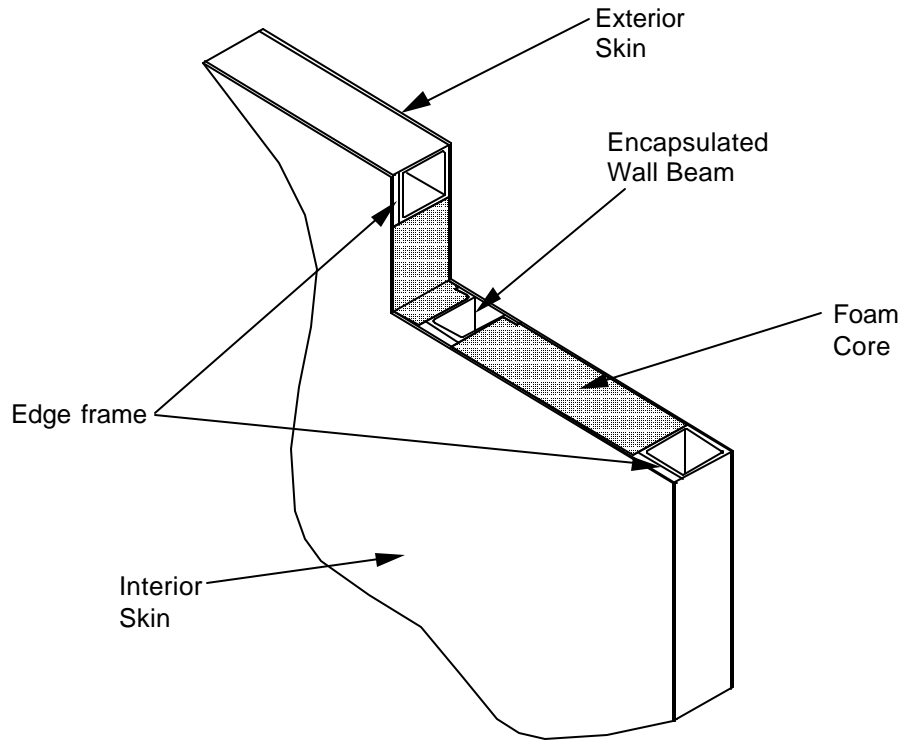
FIGURE 4.2H FOAM & BEAM SANDWICH PANEL CONSTRUCTION
