MIL-HDBK-138B  
1 JANUARY 2002

# DEPARTMENT OF DEFENSE HANDBOOK

## GUIDE TO CONTAINER INSPECTION FOR COMMERCIAL AND MILITARY INTERMODAL CONTAINERS

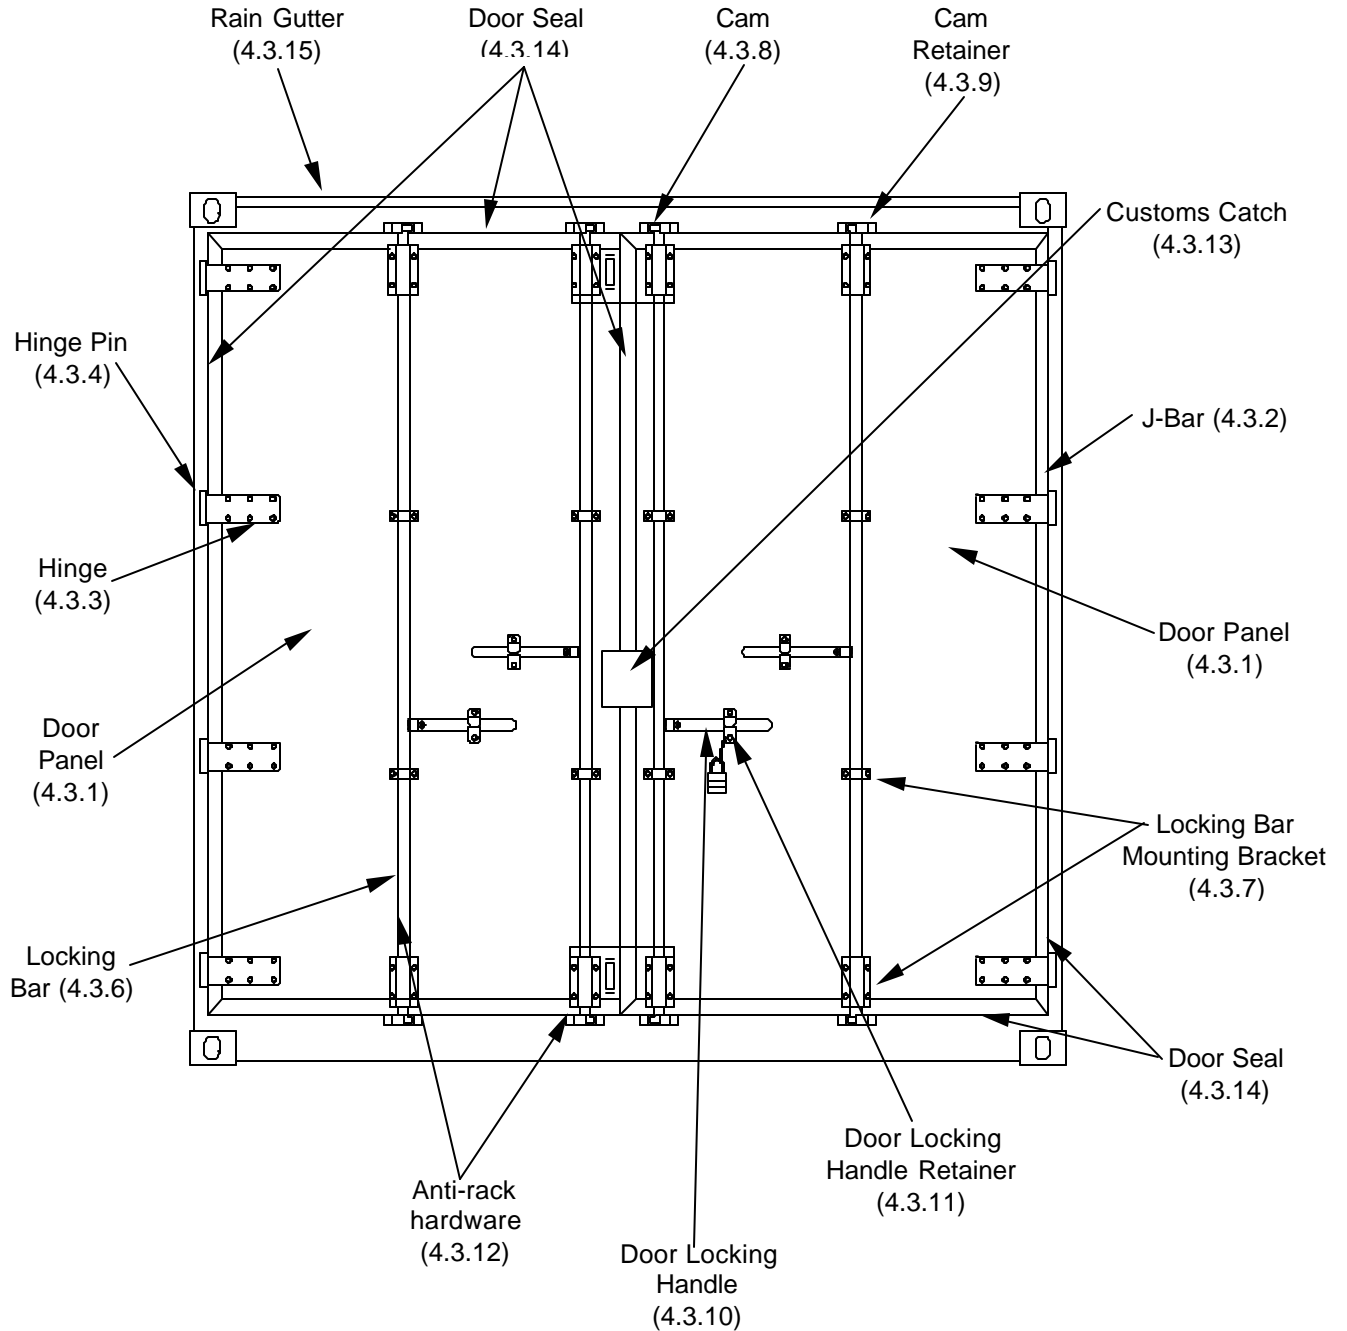
4.3.4 Hinge Pin. Hinge component that attaches the two components of the hinge and provides a line of rotation. A hinge pin may be surrounded with a bushing to reduce friction and resist corrosion.

FIGURE 4.3A TYPICAL REAR END DOOR ASSEMBLY

4.3 Door Assembly. Refer to Figures 4.3A, 4.3A1, 4.3B, 4.3C1, and 4.3C2.

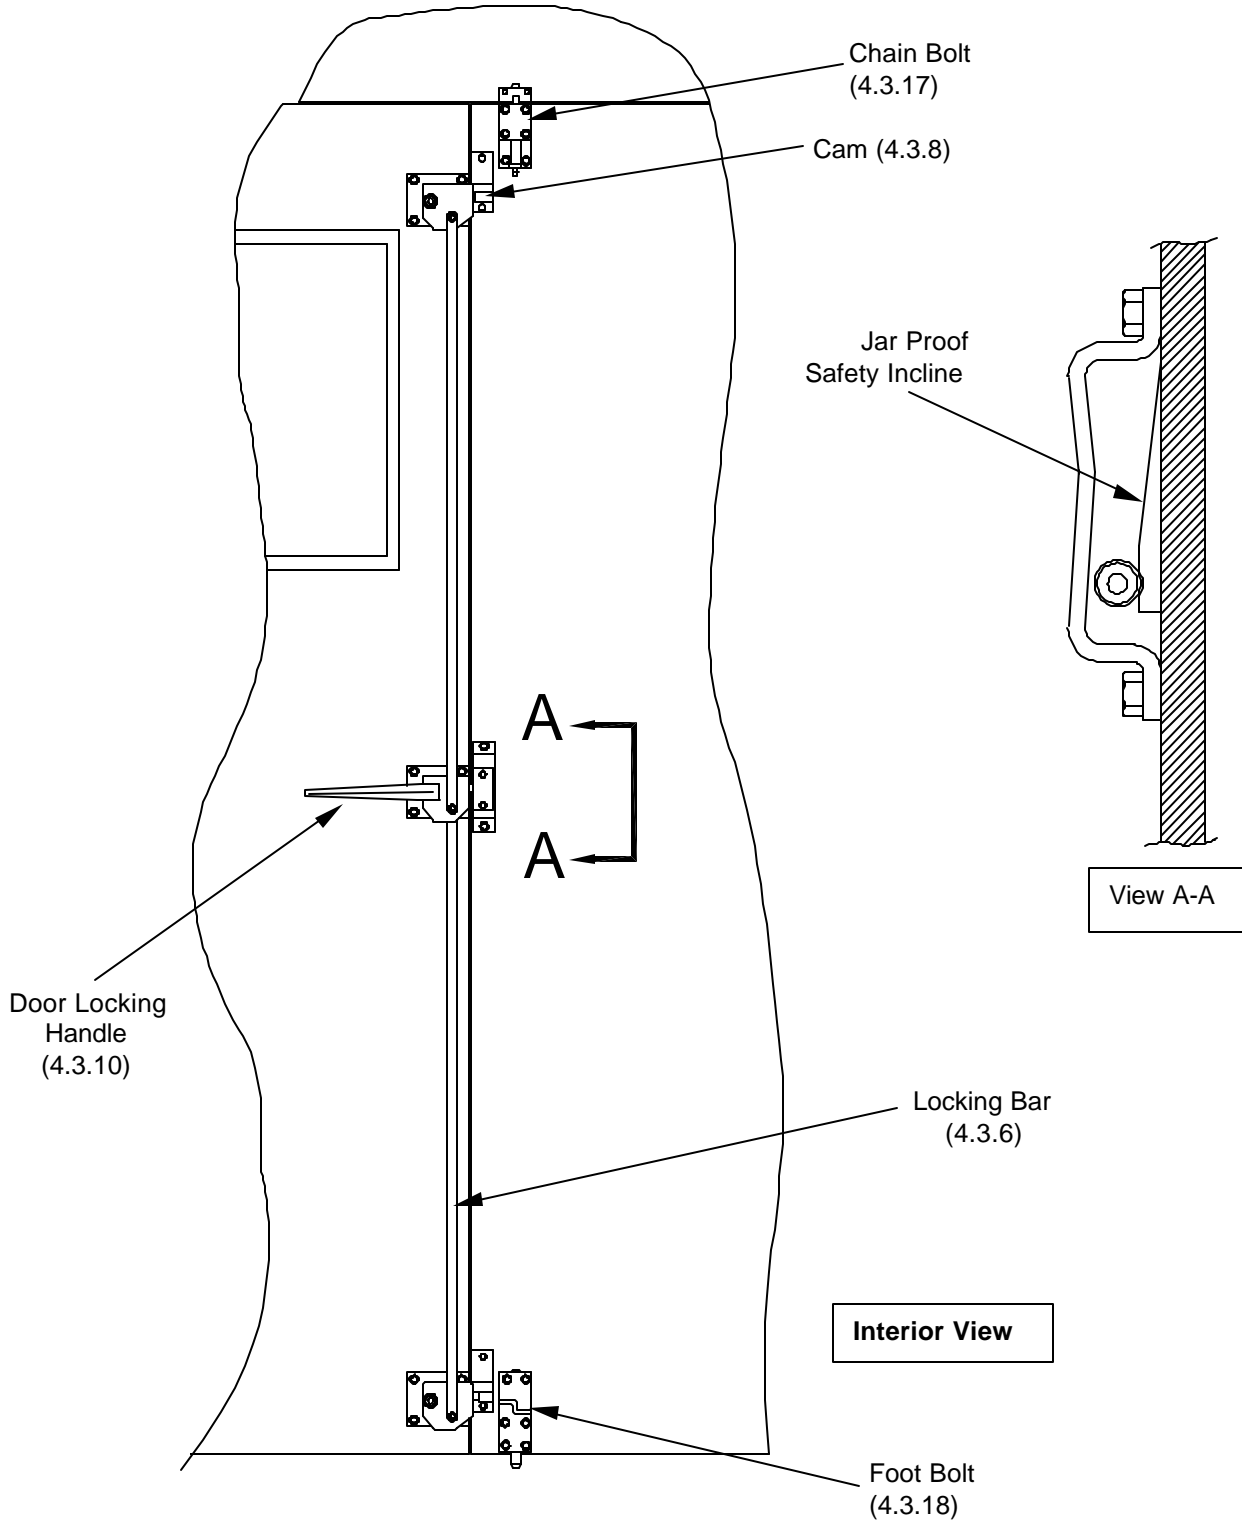
FIGURE 4.3C.1 ARMY, MARINE THREE POINT LATCHING SYSTEM

Note: For internal door locking hardware, see Figure 4.3C1 and 4.3C2

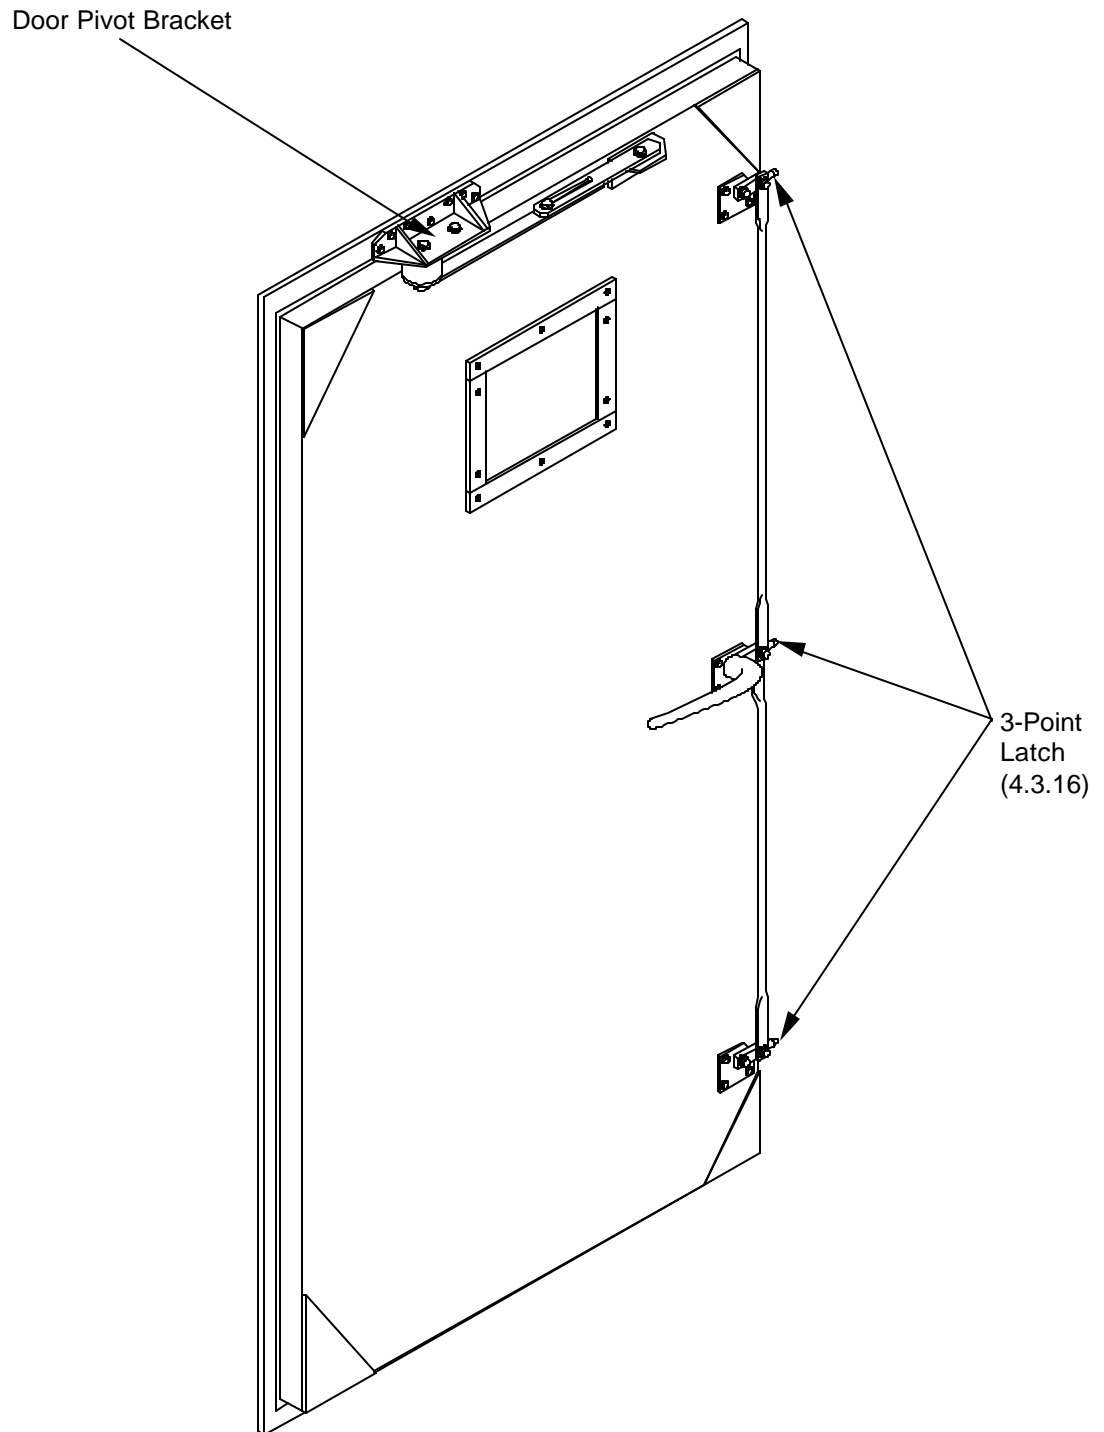
FIGURE 4.3C.2 NAVY THREE POINT LATCHING SYSTEM

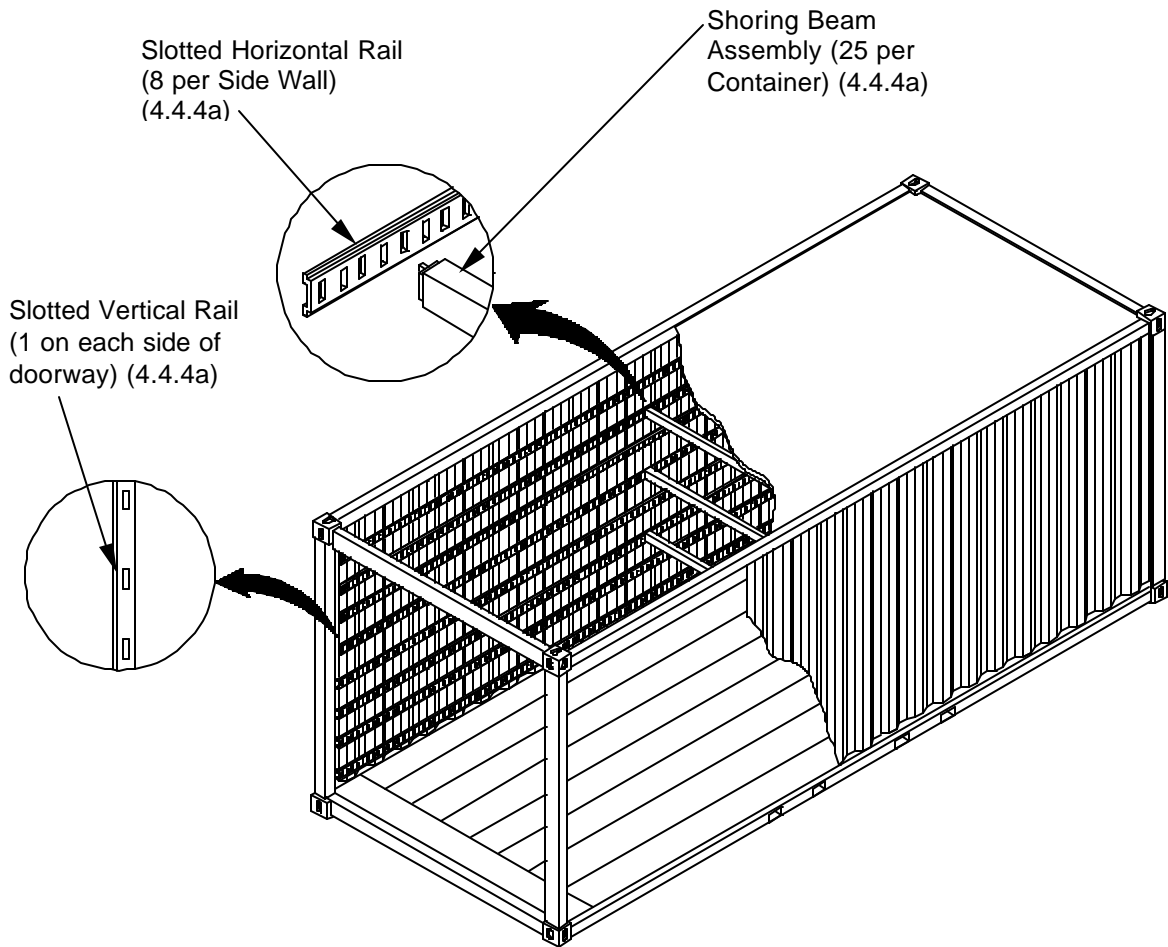
FIGURE 4.4A – MECHANICAL RESTRAINT SYSTEM FOR MILVAN

4.4 Special Terminology. Refer to Figures 4.4A, 4.4B, 4.4C, 4.4D, 4.4E, and 4.4F.

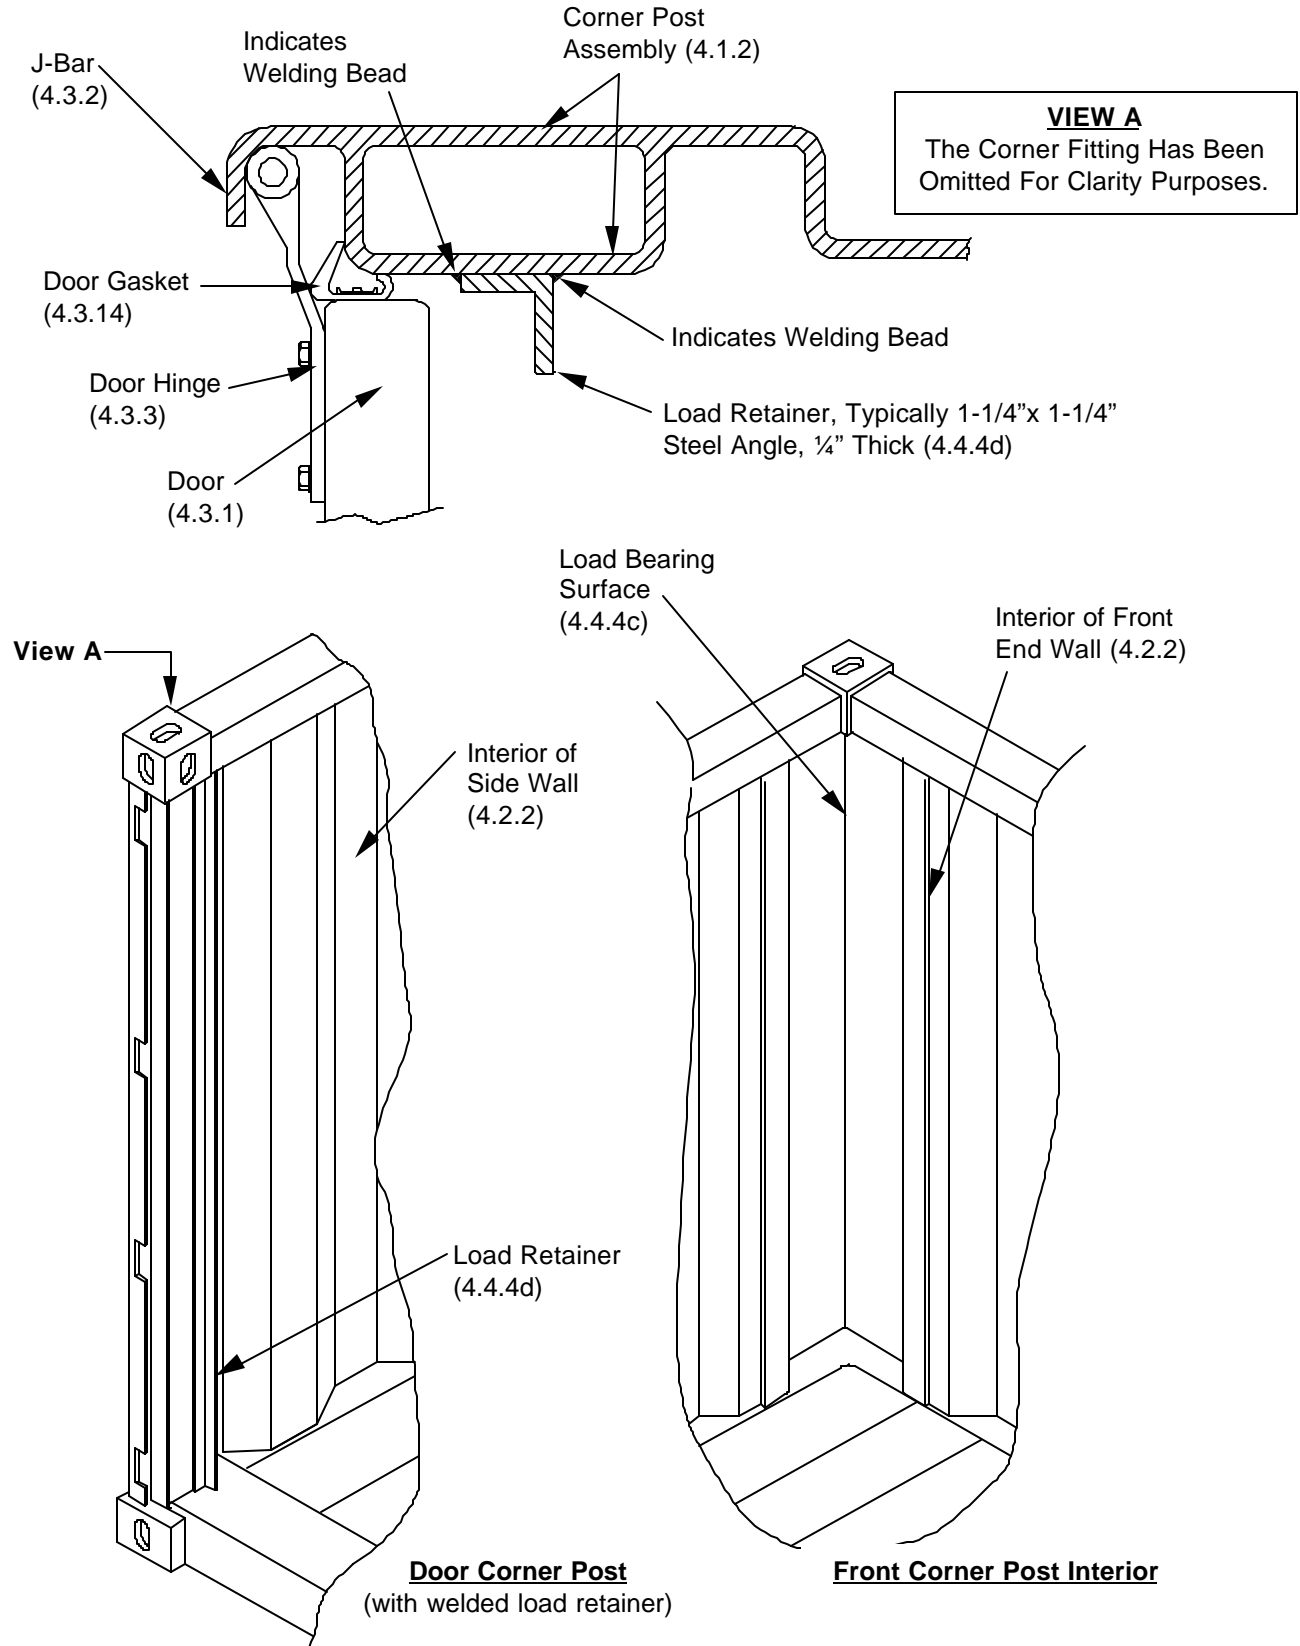
FIGURE 4.4B – CARGO RESTRAINT SYSTEM FOR END-OPENING CONTAINER

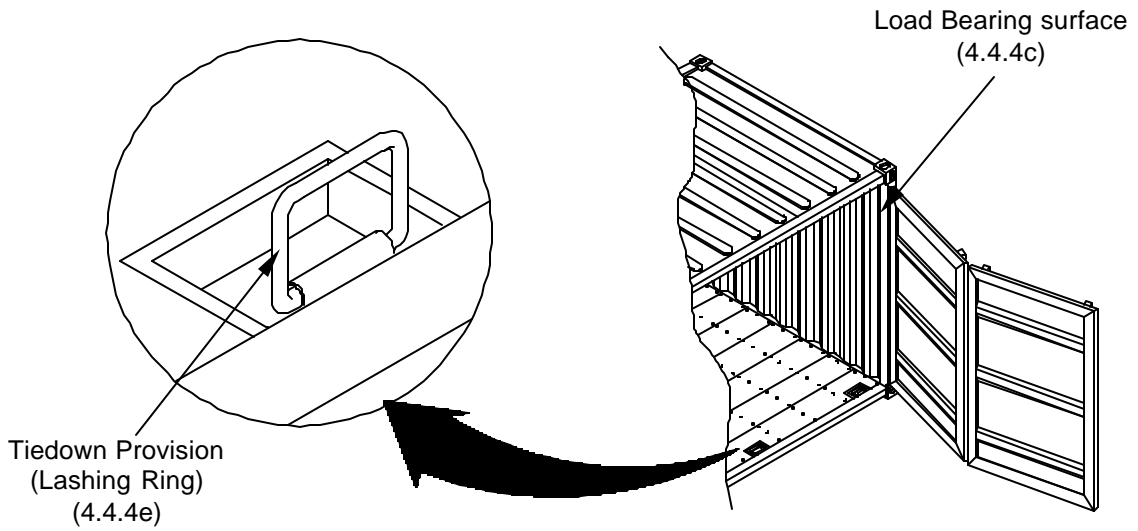
**FIGURE 4.4C – CARGO RESTRAINT SYSTEM FOR SIDE-OPENING CONTAINER**

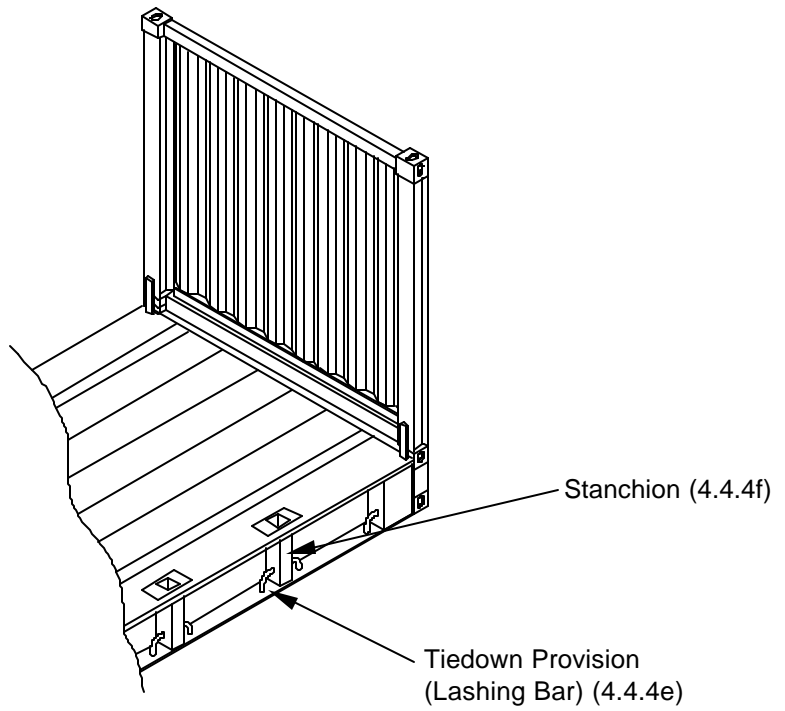
**FIGURE 4.4D – RESTRAINT PROVISION FOR FLATRACK CONTAINER**

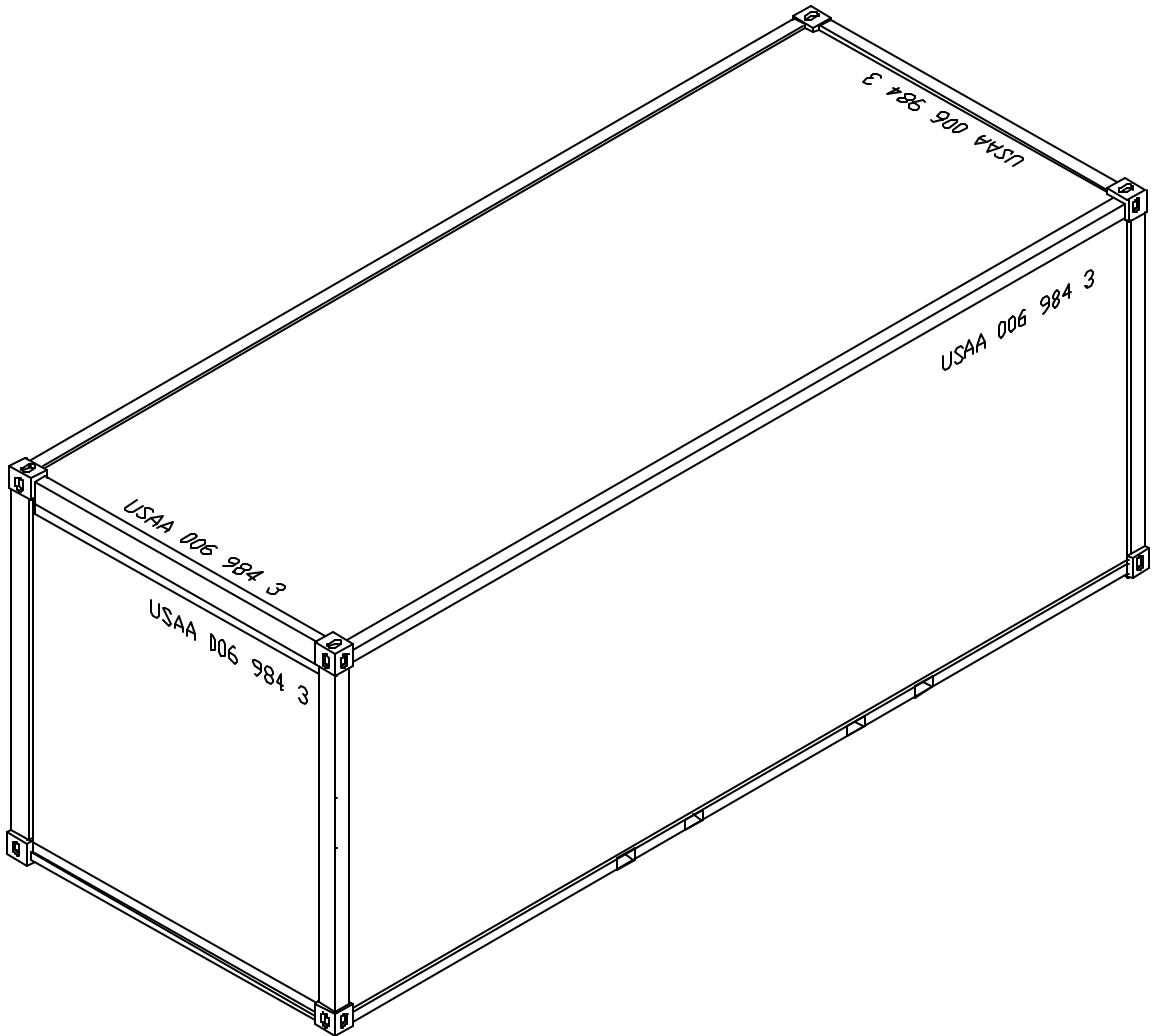
**FIGURE 4.5B –TYPICAL HORIZONTAL LAYOUT OF  
ISO IDENTIFICATION MARKINGS**

4.5 Conventions and markings. Refer to Figures 4.5A, 4.5B, 4.5C, 4.5D and 4.5E.

5.1.2 Markings and Data Plates. A container must bear legible ISO markings conforming to ISO Standard 6346. A container must also bear a legible CSC Safety Approval Plate or a Consolidated Data Plate marked in accordance with CSC format requirements. Mandatory ISO operational markings (i.e., maximum gross weight and tare weight) must appear on at least one location such as on the door, as depicted in Figure 4.5A. Mandatory ISO identification markings (i.e., owner code, serial number and check digit) must be located on all 4 sides, and top as depicted in Figures 4.5B and 4.5C. The CSC Safety Approval Plate may be securely affixed at a readily visible place on the container, where it is not easily damaged. All maximum gross weight markings on the container must be consistent with the maximum gross weight on the CSC Safety Approval Plate.

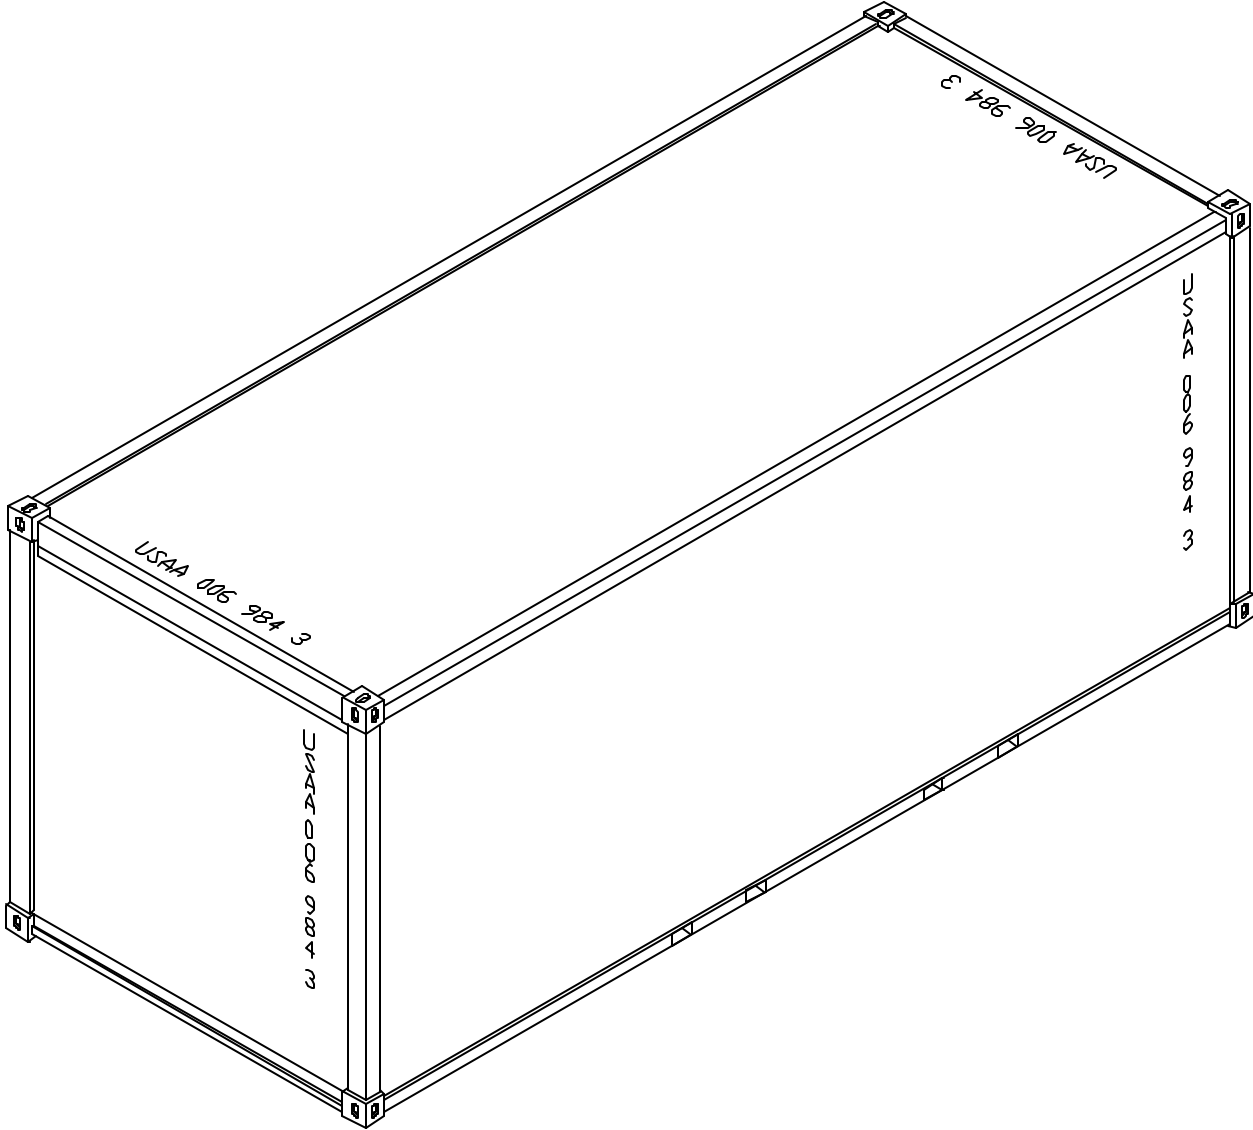
FIGURE 4.5C –TYPICAL VERTICAL LAYOUT OF ISO IDENTIFICATION MARKINGS

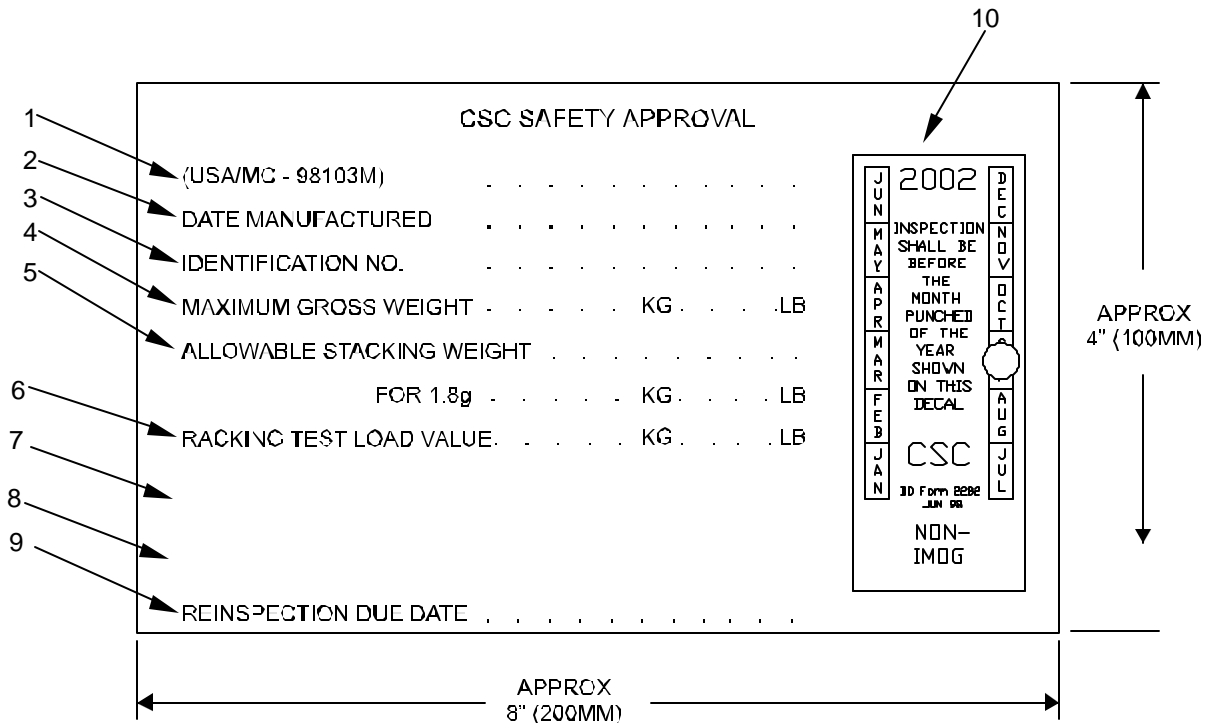
4.5.4 CSC Safety Approval Plate. A durable data plate required by CSC to indicate CSC certification by a nationally approved testing agency. The required format of the CSC Plate is depicted in Figure 4.5D. The information on the plate must be inscribed in at least the English or French language.

**REQUIRED LINES OF INFORMATION:**

1. Alphanumeric reference code similar to example shown above indicating Country of approval and reference number for approval.
2. Date (month and year) of manufacture.

**FIGURE 4.5D—TYPICAL FORMAT OF CSC SAFETY APPROVAL PLATE**

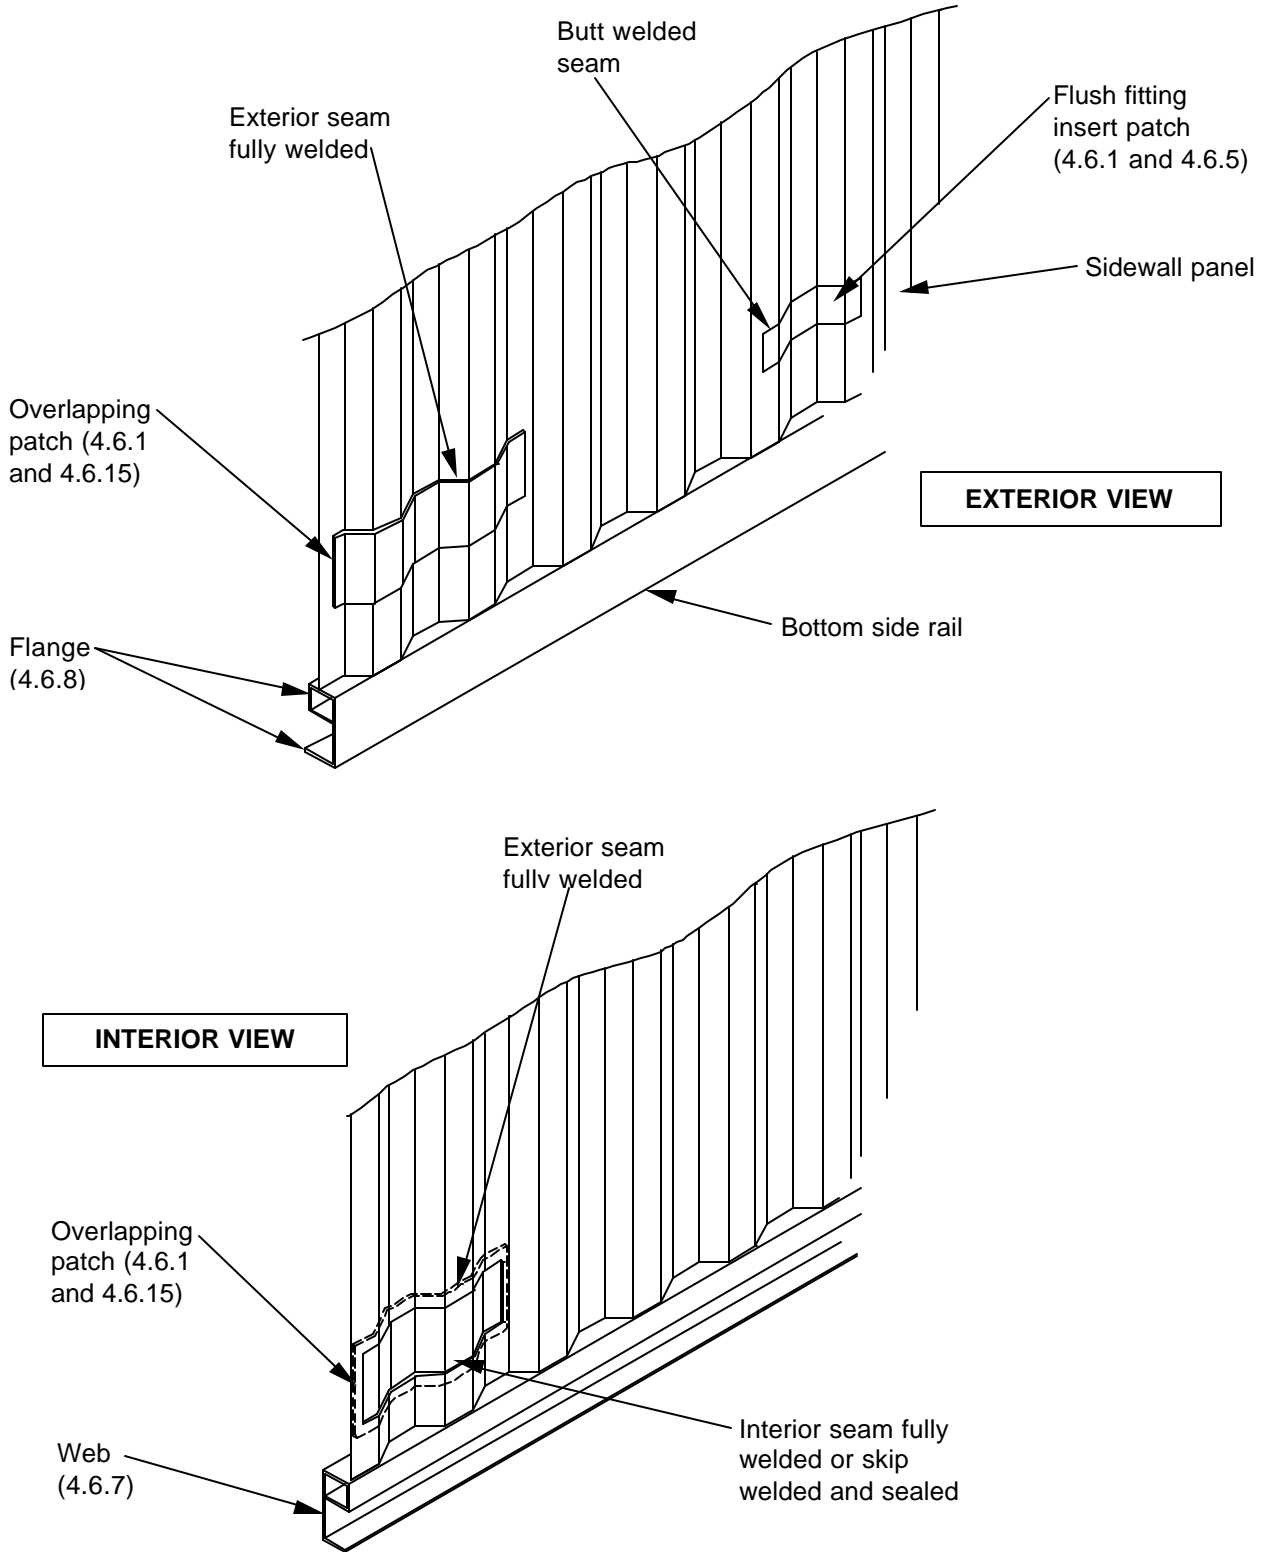
FIGURE 4.6A—TYPICAL WELDED PATCHES ON STEEL WALL PANELS

4.6 Damage and Repair. Refer to Figures 4.6A, 4.6B, 4.6C, 4.6D and 4.6E.

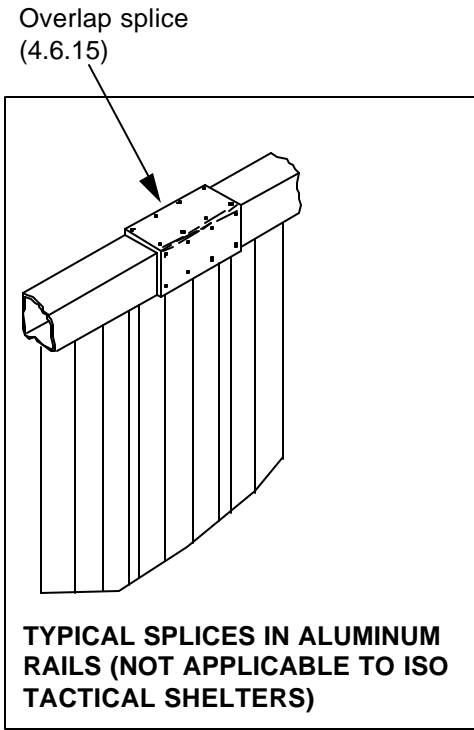
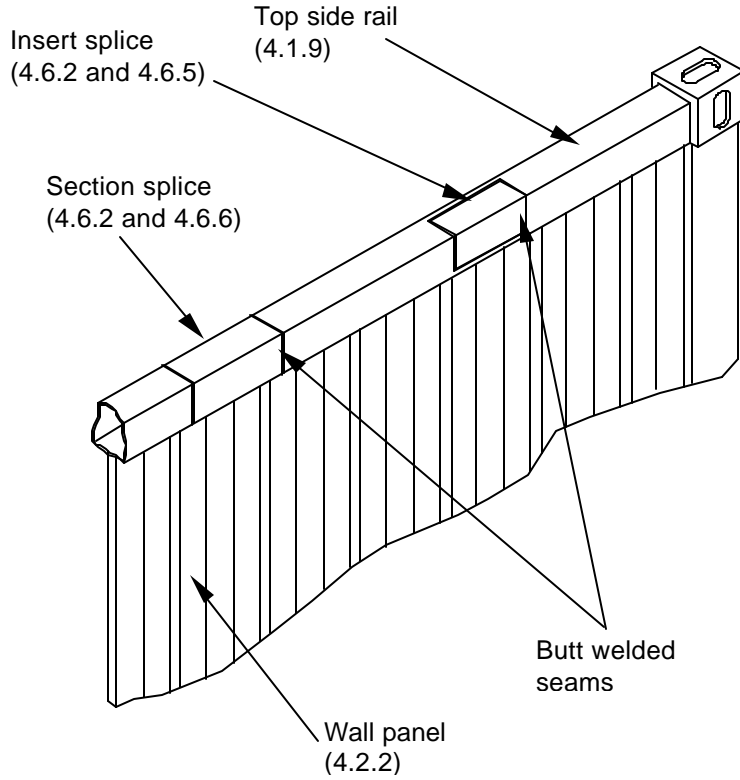
**TYPICAL SPLICES IN TOP STEEL RAILS**

**FIGURE 4.6B—TYPICAL SPLICES IN RAILS**

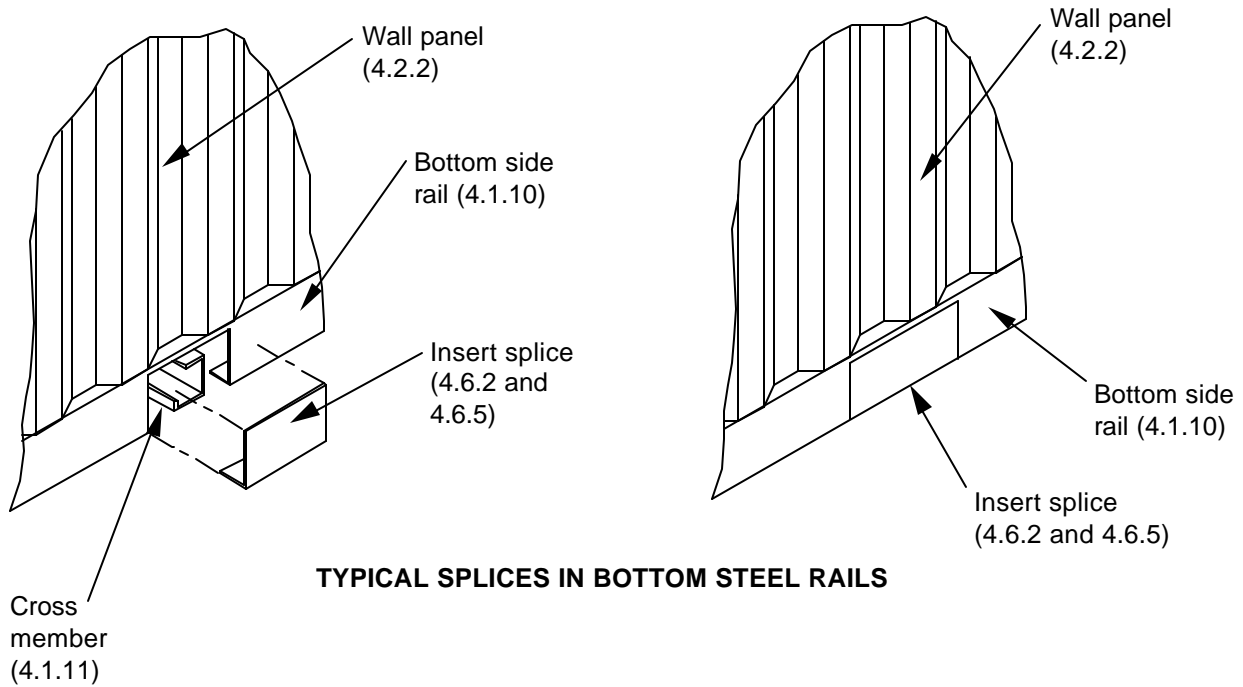
**TYPICAL SPLICES IN BOTTOM STEEL RAILS**

5.2.2 Acceptable Splicing. For purposes of these criteria, a splice is any repair of a primary structural member that replaces material without complete replacement of the member. Areas repaired by straightening and/or bead welding are not to be construed as splices. Gussets, backup plates or other reinforcement (protector) plates are not to be construed as splices. An acceptable splice on steel rails is butt-welded, flush-fitting and restores the original size and cross-sectional profile of the repaired component. On aluminum rails, splice may overlap the damaged area (overlapped or lapped splice) and will be riveted. An acceptable splice is a minimum of 6 inches (150mm) long. Both inserts and section (full profile) are acceptable types of splices, but not in all cases. Read inspection criteria of the component for specific splicing allowances. If a splice would end within 12 inches (300mm) of another weld, such as at the juncture with the corner fitting, it must be extended to that weld. Backup plates installed on the backside of a splice are permissible if the backup plate extends a minimum of 6 inches (150mm) beyond each end of the splice.

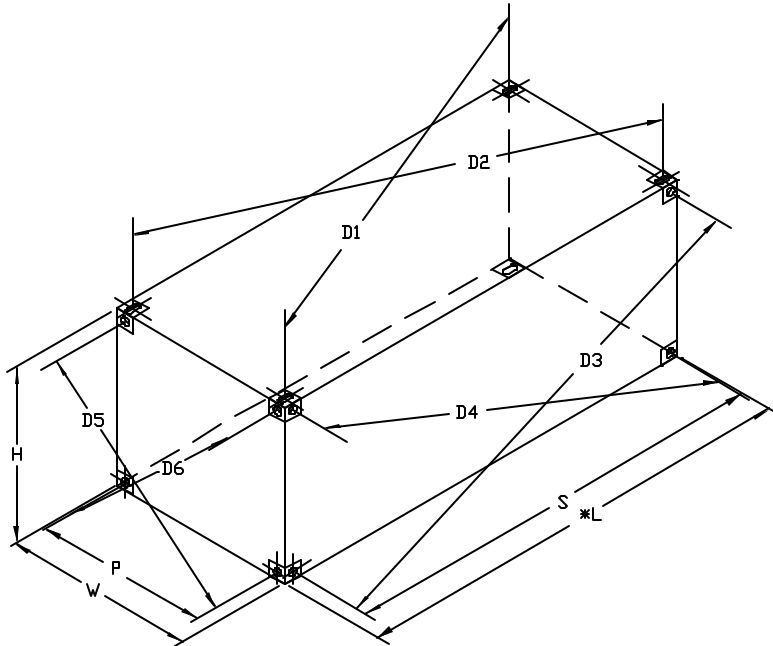
5.1.3 Configuration. Any distortion of the overall configuration great enough to preclude proper engagement of handling/lifting equipment, mounting and securing on chassis, vehicle, or aircraft pallet, or insertion into the cell of a ship is unacceptable. No part of the container may protrude beyond the outside surfaces of the corner fittings. The external dimensions must be within the tolerances prescribed by ISO standard 668 as depicted in Figure 5.1.

**SPECIAL NOTE FOR FLATRACKS ONLY:** In accordance with ISO standard 1496 part 5, an additional tolerance of +/-3/8 inch (+/-10mm) is allowed for the top external length L of flatrack containers. For example, the maximum permitted overall top dimension of a nominal 20 foot flatrack is 19 feet 10-7/8 inches (6,068mm) when empty and the minimum permitted overall top dimension is 19 feet 9-7/8 inches (6,042mm) when loaded to rated capacity.

- 5) Any deformation such as a dent, bend or bow that is in excess of ISO external dimensional tolerances as depicted in Figure 5.1;
- 6) More than two splices or an improper splice (5.2.2). A splice must not extend through or across more than ½ the cross-sectional profile of the post;

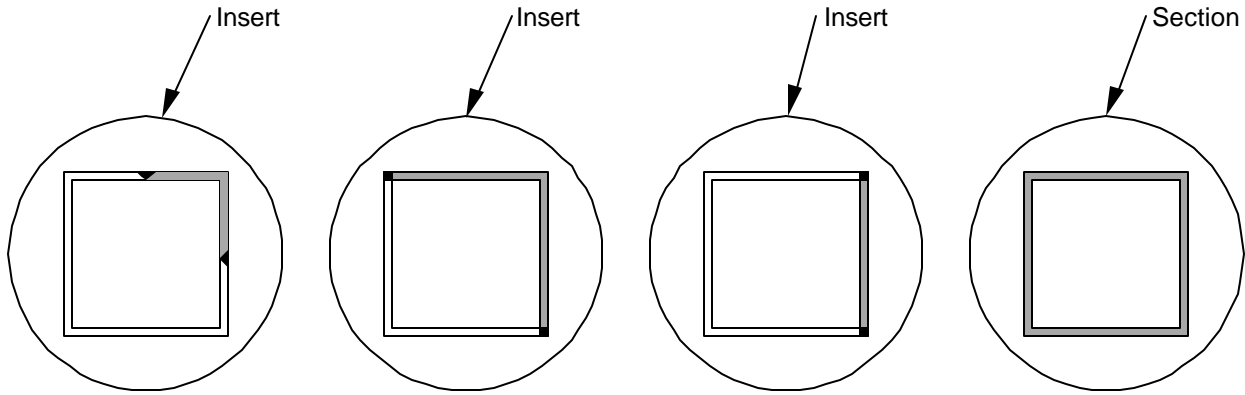
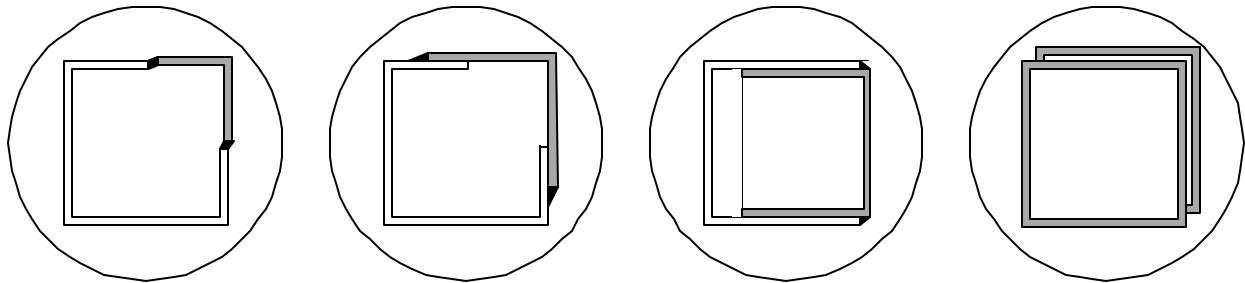
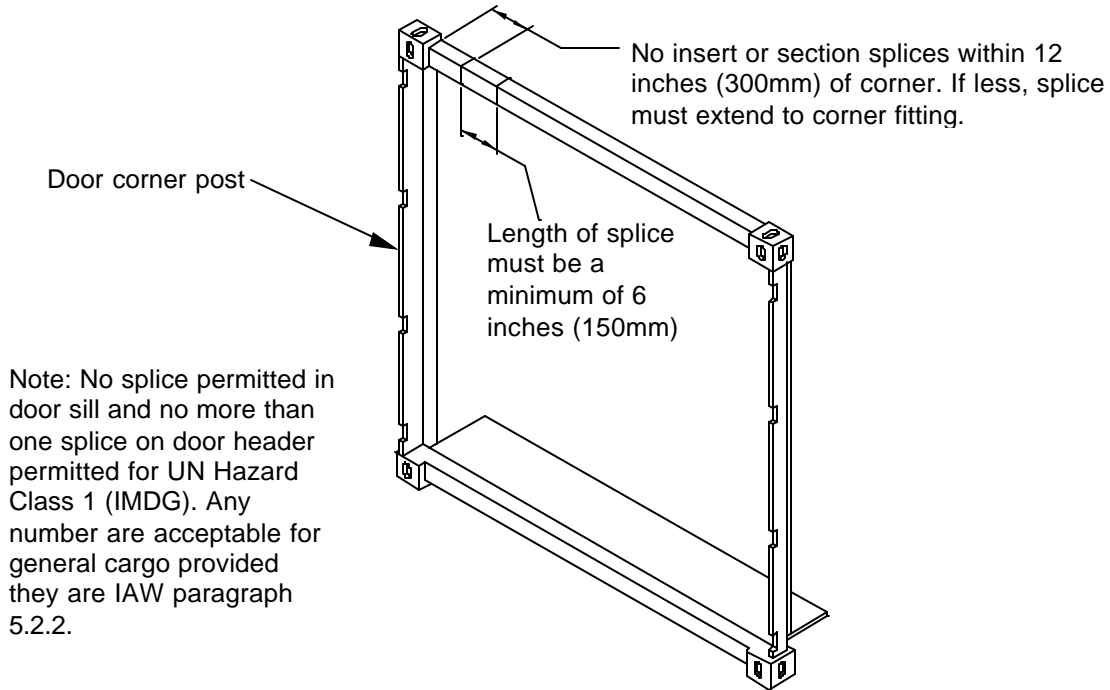
**FIGURE 5.2.7B – SPLICE LIMITATIONS FOR DOOR HEADER AND SILL**

Examples of Acceptable Header and Door Sill (non IMDG) Splices

Improper Splices – Inserts not flush with remaining rail

Section not in line with rail

5.2.7 Door End Frame. Refer to Figures 5.2.7A and 5.2.7B. A container is unacceptable if a rear end frame has any major defect.

- 1) A dent or bend in the door header or the door sill that is greater than 3/4 inch (19mm) in depth, regardless of length.
- 2) More than one splice in a door header.
- 3) Any splice in a door sill.

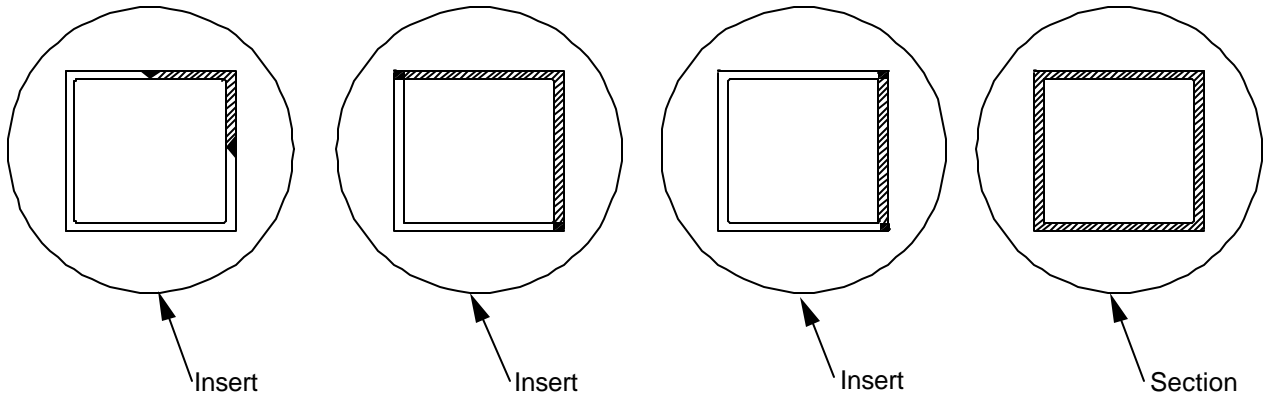
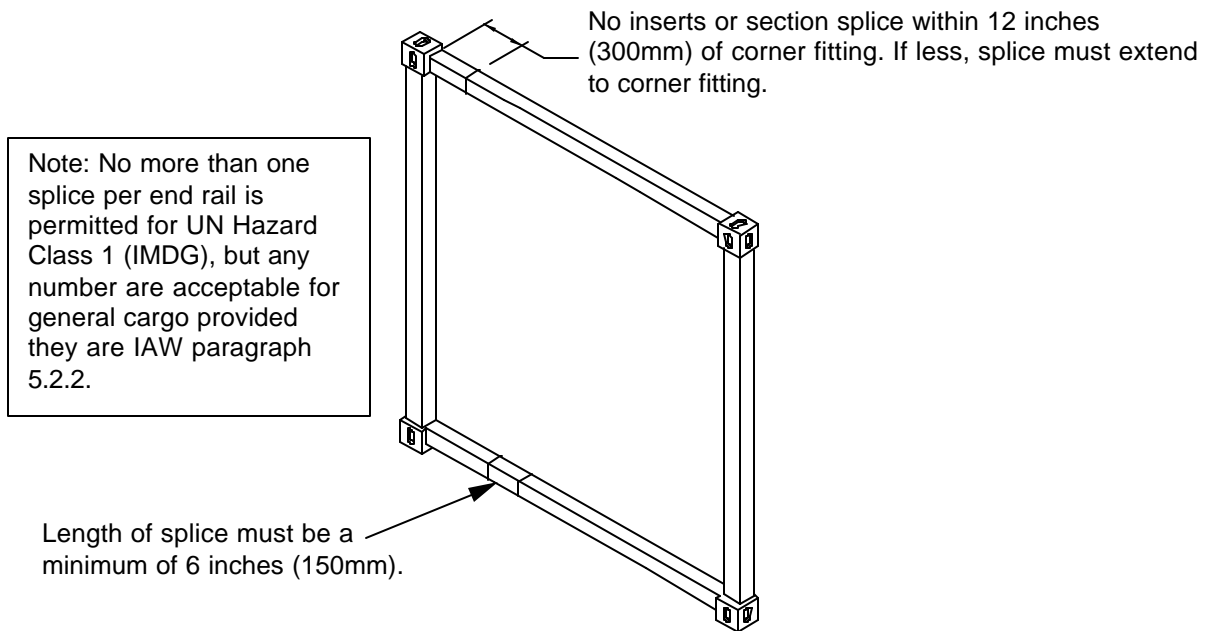
**FIGURE 5.2.8B – SPLICE LIMITATIONS FOR END RAILS**

Examples Of Acceptable End Rail Splices

Improper Splices – Inserts Not Flush With Remaining Rail

5.2.8 End Frame. (Without Door) Refer to Figures 5.2.8A and 5.2.8B. A container is unacceptable if an end frame has any major defect.

- 7) An improper splice in top or bottom end rail;
- 8) Any splice in a steel rail other than a butt welded insert or full profile splice; or
- 9) Any splice on an aluminum rail other than an overlap riveted splice.

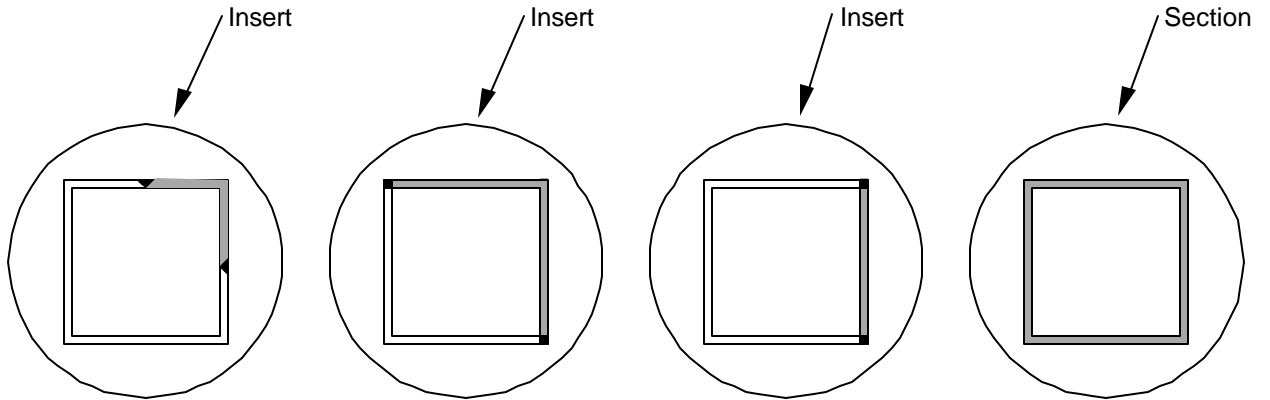
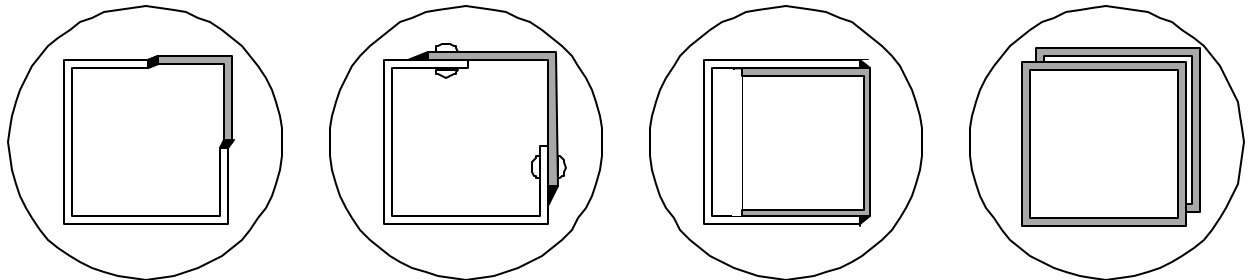
**FIGURE 5.2.9D – EXAMPLES OF STEEL TOP SIDE RAIL SPLICES**

Examples Of Acceptable Top Side Rail Splices

Improper Splices – Inserts Not Flush With Remaining Rail

5.2.9 Side Rails. Refer to Figures 5.2.9A, 5.2.9B, 5.2.9C, 5.2.9D and 5.2.9E. A container is unacceptable if a side rail has any major defect.
