MIL-HDBK-138B  
1 JANUARY 2002

# DEPARTMENT OF DEFENSE HANDBOOK

## GUIDE TO CONTAINER INSPECTION FOR COMMERCIAL AND MILITARY INTERMODAL CONTAINERS

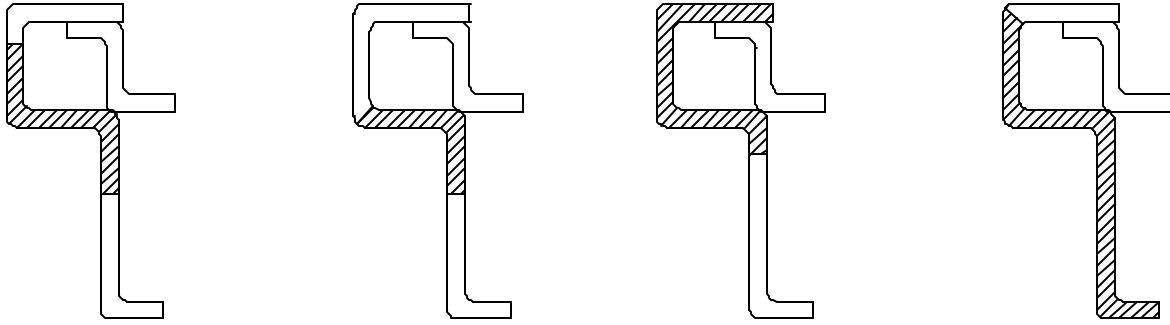
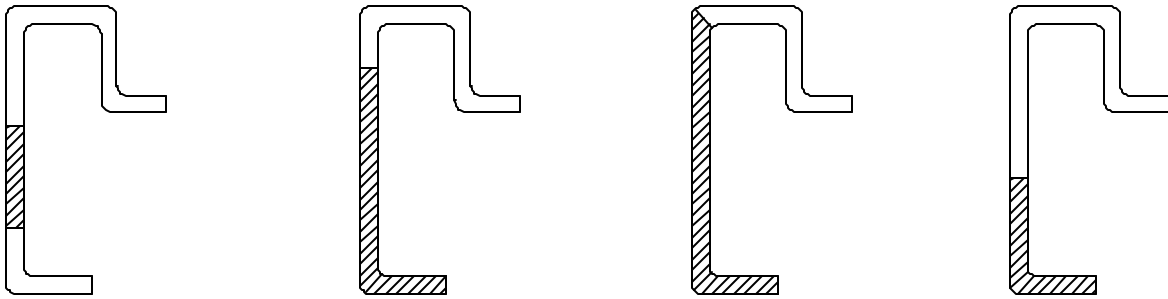
**FIGURE 5.2.9E – EXAMPLES OF STEEL BOTTOM SIDE RAIL SPLICES**

**Note:** Figures depict cross sectional profiles of bottom side rails. All examples shown are acceptable insert splices. Full profile section splices are also acceptable.

5.2.9 Side Rails. Refer to Figures 5.2.9A, 5.2.9B, 5.2.9C, 5.2.9D and 5.2.9E. A container is unacceptable if a side rail has any major defect.

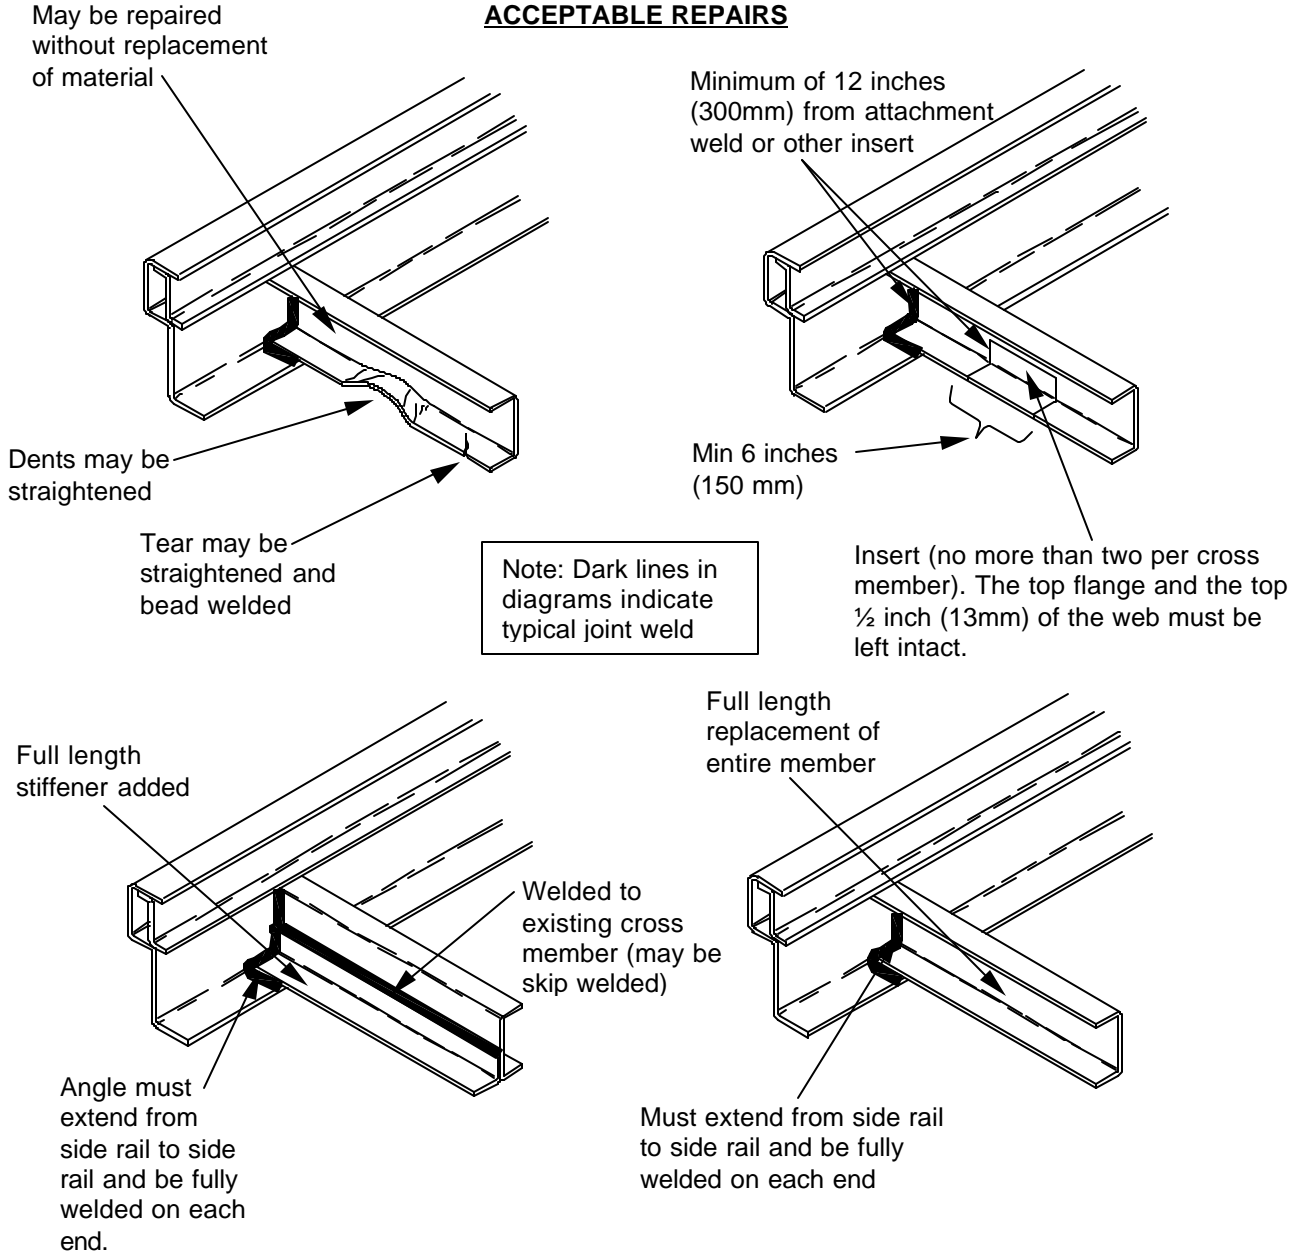
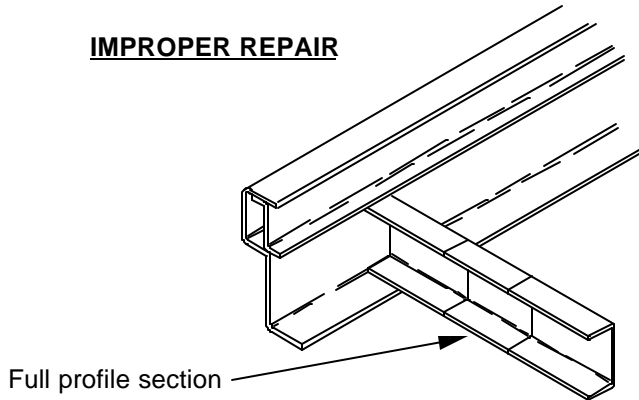
**FIGURE 5.2.10A – STEEL CROSS MEMBER REPAIR LIMITATIONS**

**ACCEPTABLE REPAIRS**

**IMPROPER REPAIR**

5.2.10 Floor Cross Members. Refer to Figures 5.2.10A, 5.2.10B, 5.2.10C, and 5.2.10D. Floor cross members are considered to be a part of the primary structure and a container is unacceptable if any floor cross member has any major defect.

- 7) More than two splices, an improper splice, or any full profile splice;
- 8) Any splice in a steel cross member other than a butt welded insert;
- 9) Any splice on an aluminum cross member other than an overlap riveted splice;

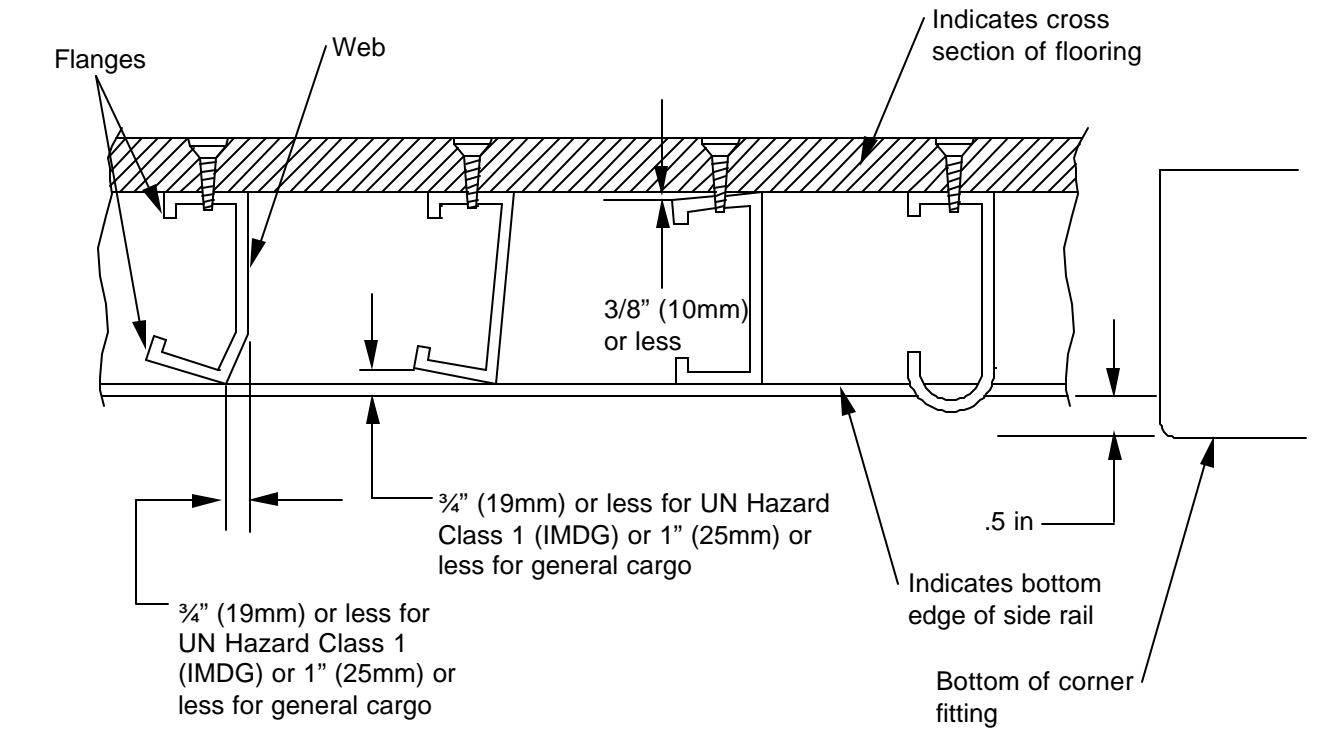
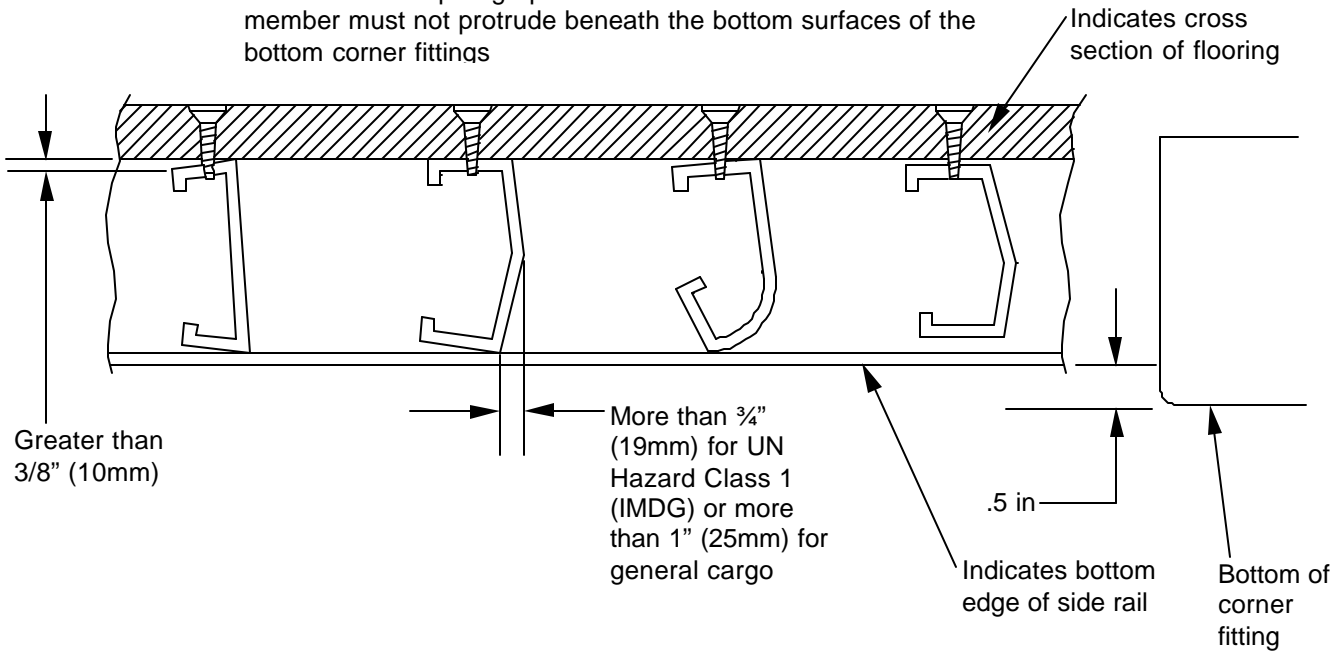
**FIGURE 5.2.10B – DENT AND BEND LIMITATIONS FOR CROSS MEMBERS**

**ACCEPTABLE CROSS MEMBERS**

Note: Criteria of paragraph 5.2.10 must be met and cross member must not protrude beneath the bottom surfaces of the bottom corner fittings

**UNACCEPTABLE CROSS MEMBERS**

5.2.15 Structural Integrity of Understructure. Slightly oxidized (rusted), twisted, bent, dented, or bowed floor cross members are not a cause for rejection provided criteria of paragraph 5.2.10 is met, welds are not broken, and in the judgement of the inspector, the structural integrity of the container has not been reduced beyond safe limits. If the strength of the floor is in doubt, the dynamic floor weight test specified in Annex II of the International CSC should be conducted to ascertain that: the understructure does not deflect more than 1/4 inch (7mm) below the bottom surfaces of the bottom corner fittings; no component is permanently deformed; and no component or weld fails.

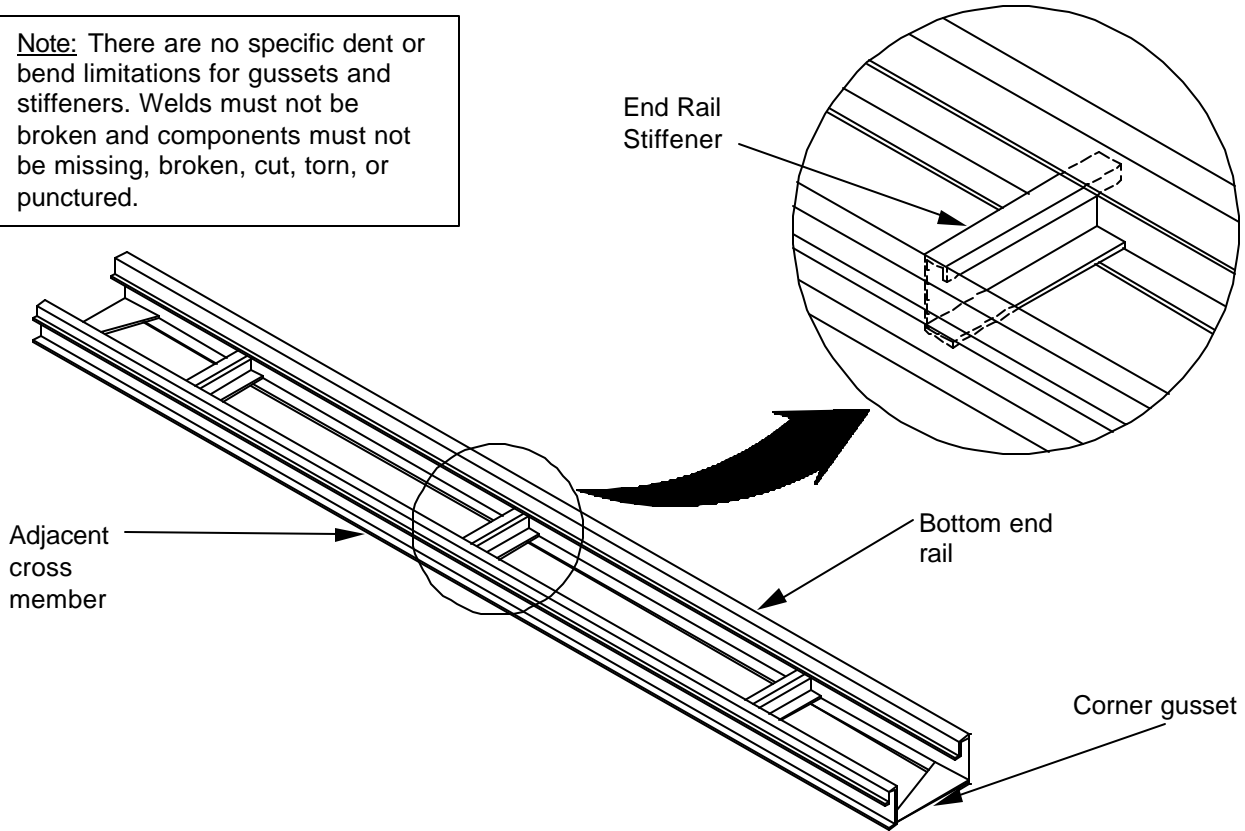
**FIGURE 5.2.14 – GUSSETS AND END RAIL STIFFENERS ON STEEL CONTAINERS**

Note: There are no specific dent or bend limitations for gussets and stiffeners. Welds must not be broken and components must not be missing, broken, cut, torn, or punctured.

5.2.14 Gussets and End Rail Stiffeners. There are no specific dent or bend limitations for gussets and end rail stiffeners. Dents and bends not affecting the structural integrity of the container are permissible. A container is unacceptable if any weld is broken, if there are any loose or missing fasteners, or a gusset or stiffener is missing, broken, cut, torn or punctured. Refer to Figure 5.2.14.

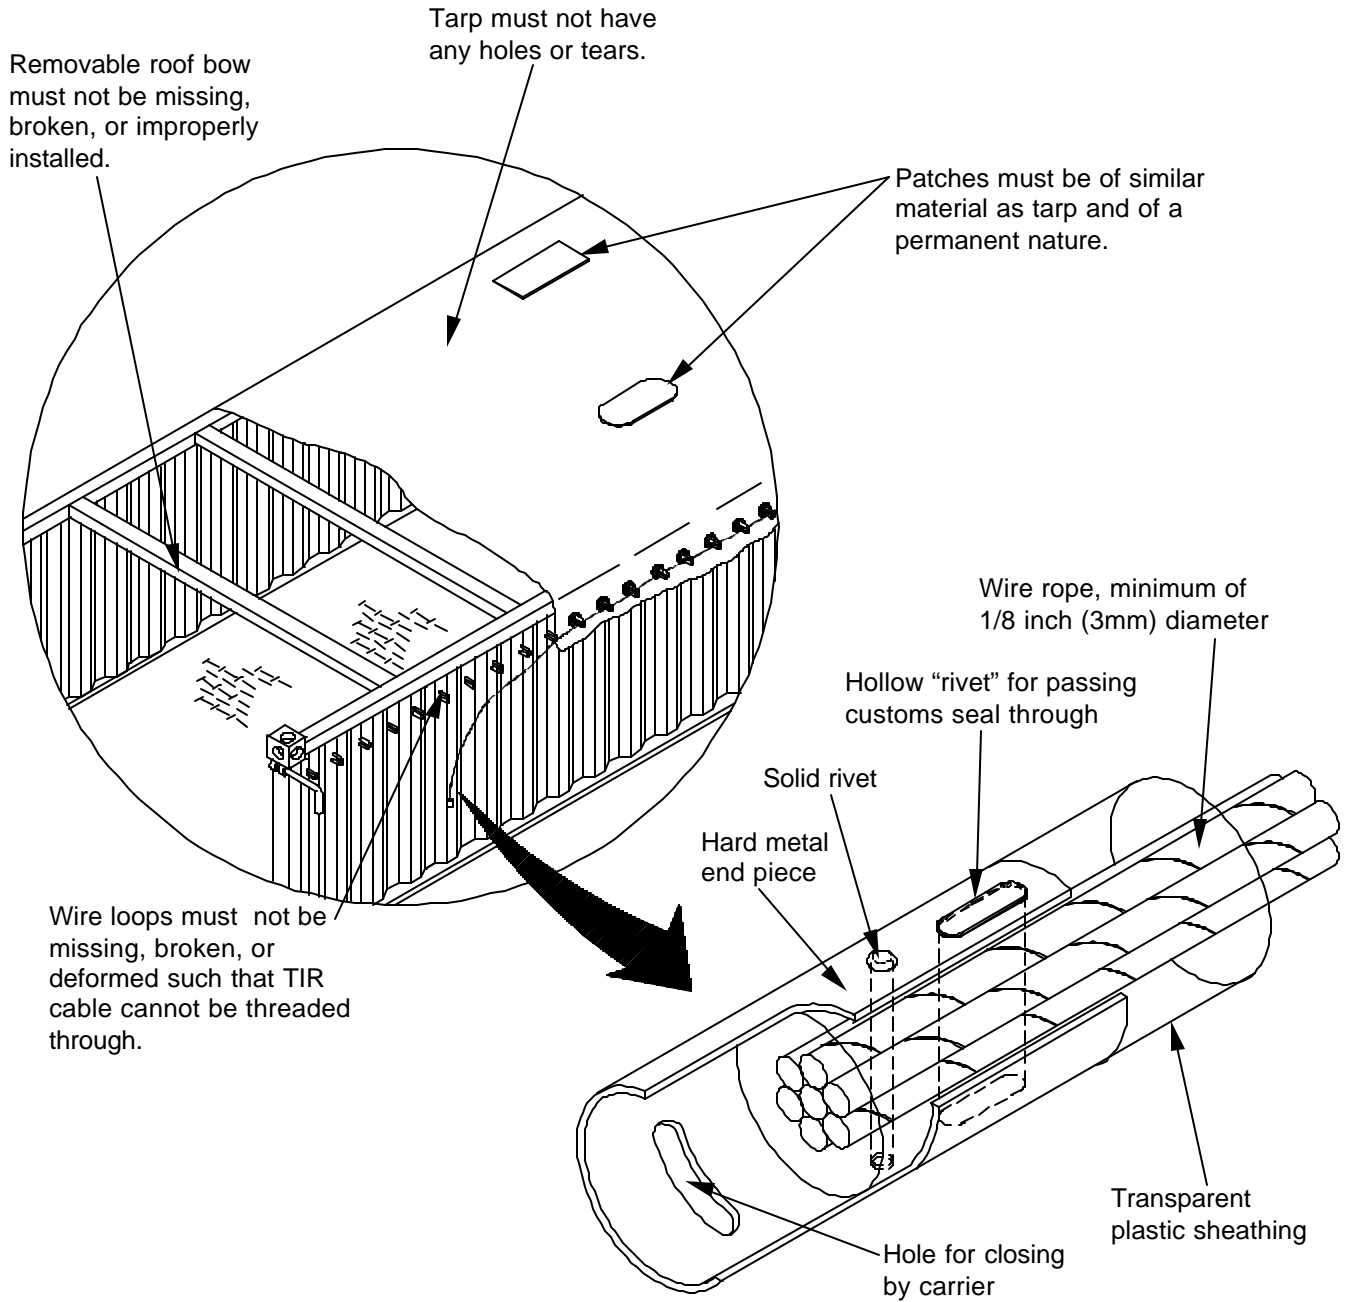
**FIGURE 5.3.5 – REMOVABLE COVER (TARP) ASSEMBLY**

**TERMINAL FOR TIR CABLE**

5.3.5 Removable Cover (Tarp) Assembly. Refer to Figure 5.3.5. Removable roof bows, tarp and TIR cable are used with an open top container. They must be inspected to ensure serviceability and weather-proof integrity when installed on the container. A container is unacceptable for shipping any kind of cargo if any of the following deficiencies are evident:

- a. A roof bow is missing or is damaged and cannot be installed properly;
- b. Any hole or tear in the tarp;
- c. Tarp does not prevent seepage of water;
- d. Tarp cannot be affixed to the upper portion of the container with a TIR customs approved sealing technique;
- e. Reinforced eyelets in perimeter of tarp not fitting (nesting) correctly over corresponding loops welded on the side panels, end panels, and doors;
- f. Welded loops missing, broken, or deformed so TIR cable (plastic sheathed wire rope) cannot be threaded through all of them;
- g. TIR cable damaged beyond use; or
- h. Terminal on the end of the TIR cable unusable or missing.

5.3.6 Serviceability of Cover (Tarp) Assembly. Neatly made repairs (patches) in the tarp are permissible provided they are of similar material and seal against the penetration of water. All repairs, regardless of size, must be of a permanent nature such as a heat-sealed vinyl patch. Patches must not overlap other patches. Cracked or missing sections of the plastic sheathing on the TIR cable are acceptable provided the wire rope core is not broken and the cable can be properly installed.

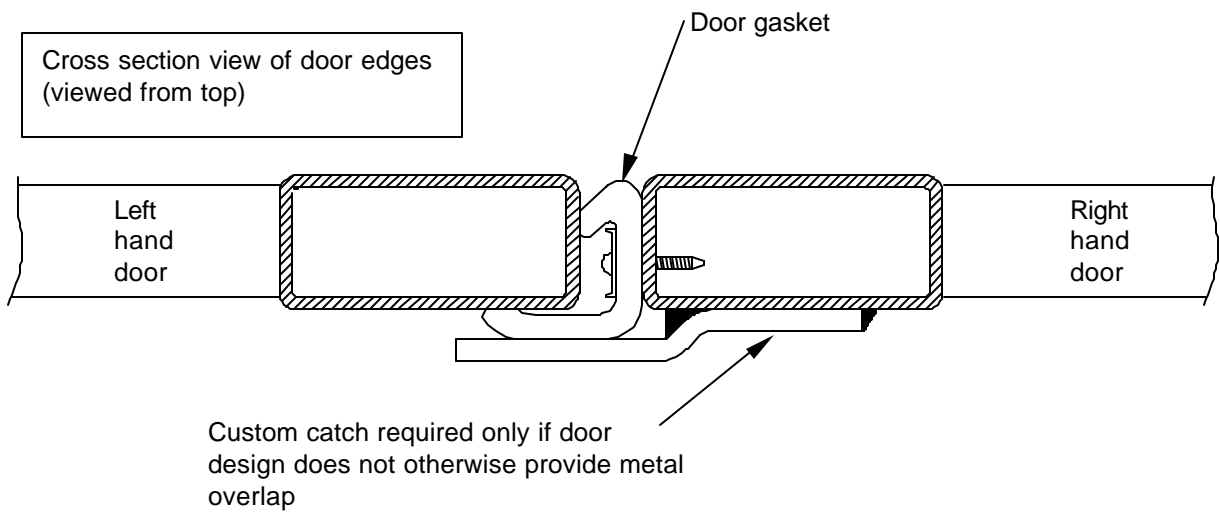
FIGURE 5.3.7D – CUSTOMS CATCH ON A STEEL DOOR

Note: For internal door locking hardware, see Figure 4.3C1 and 4.3C2

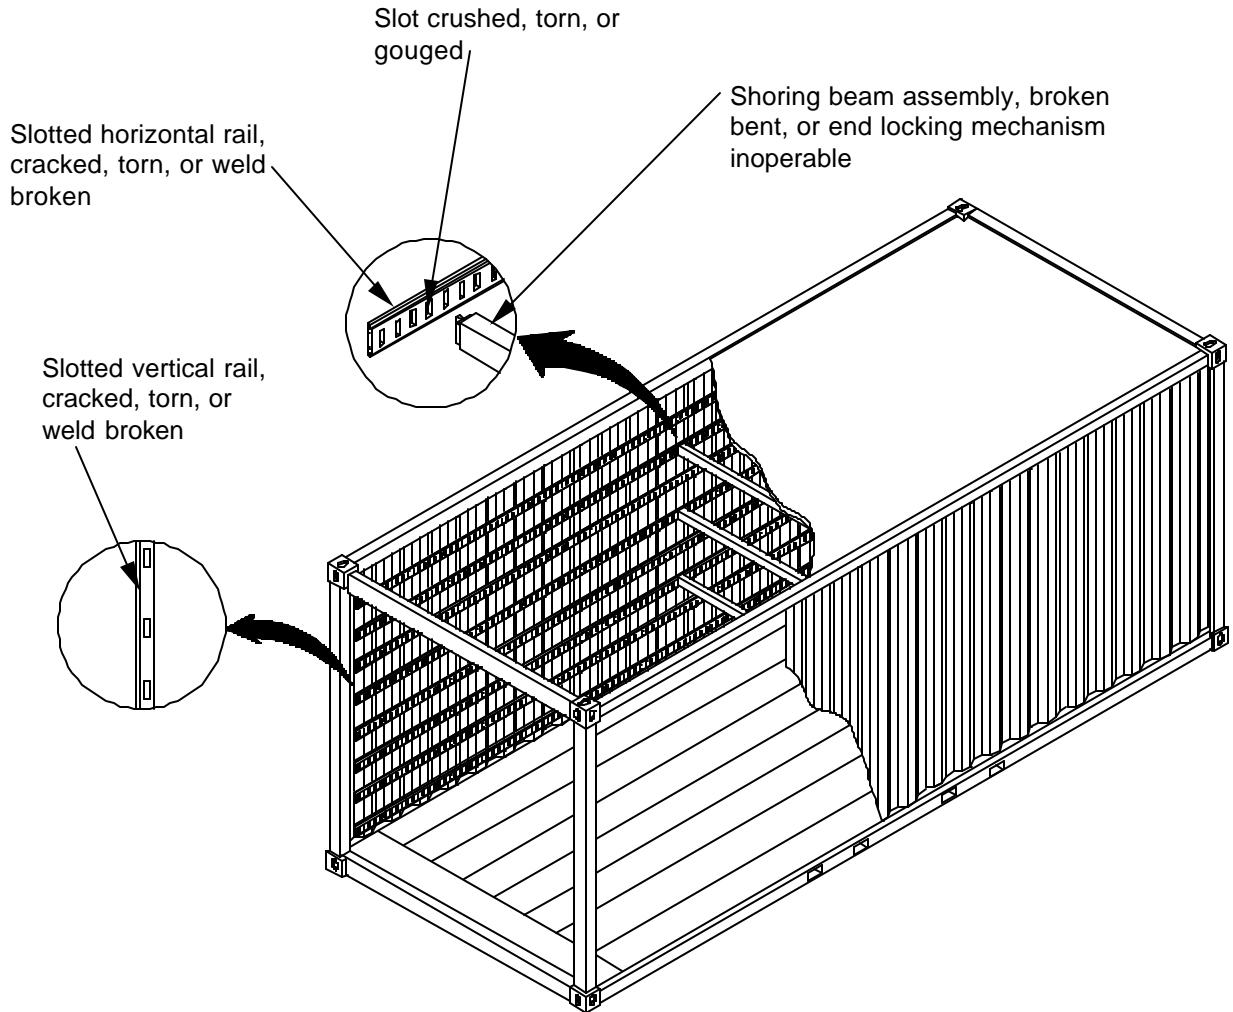
FIGURE 5.3.9A – MECHANICAL RESTRAINT SYSTEM DAMAGE

a. Mechanical Restraint System. The mechanical restraint system used in an end-opening container must be in working order if required for cargo securement. Horizontal or vertical rails must not be bent or distorted, must not have cracked or suspect welds, and must not have crushed or gouged slots. Horizontal or vertical rails that have crushed or gouged slots are not cause for rejection of the container as long as the damaged slots are not required for securing the cargo and the structural integrity of the rail is not otherwise impaired. Shoring beam assemblies that are broken, bent, or have an inoperable locking mechanism on either end must be rejected for use.

5.3.9 Cargo Restraint. Refer to Figures 5.3.9A, 5.3.9B, 5.3.9C, and 5.3.9D. The cargo restraint system or fixtures, when present and necessary for cargo securement, must be in working order. Containers without a cargo restraint system will be configured so as to provide sufficient load bearing surfaces for safe support of dunnage materials.

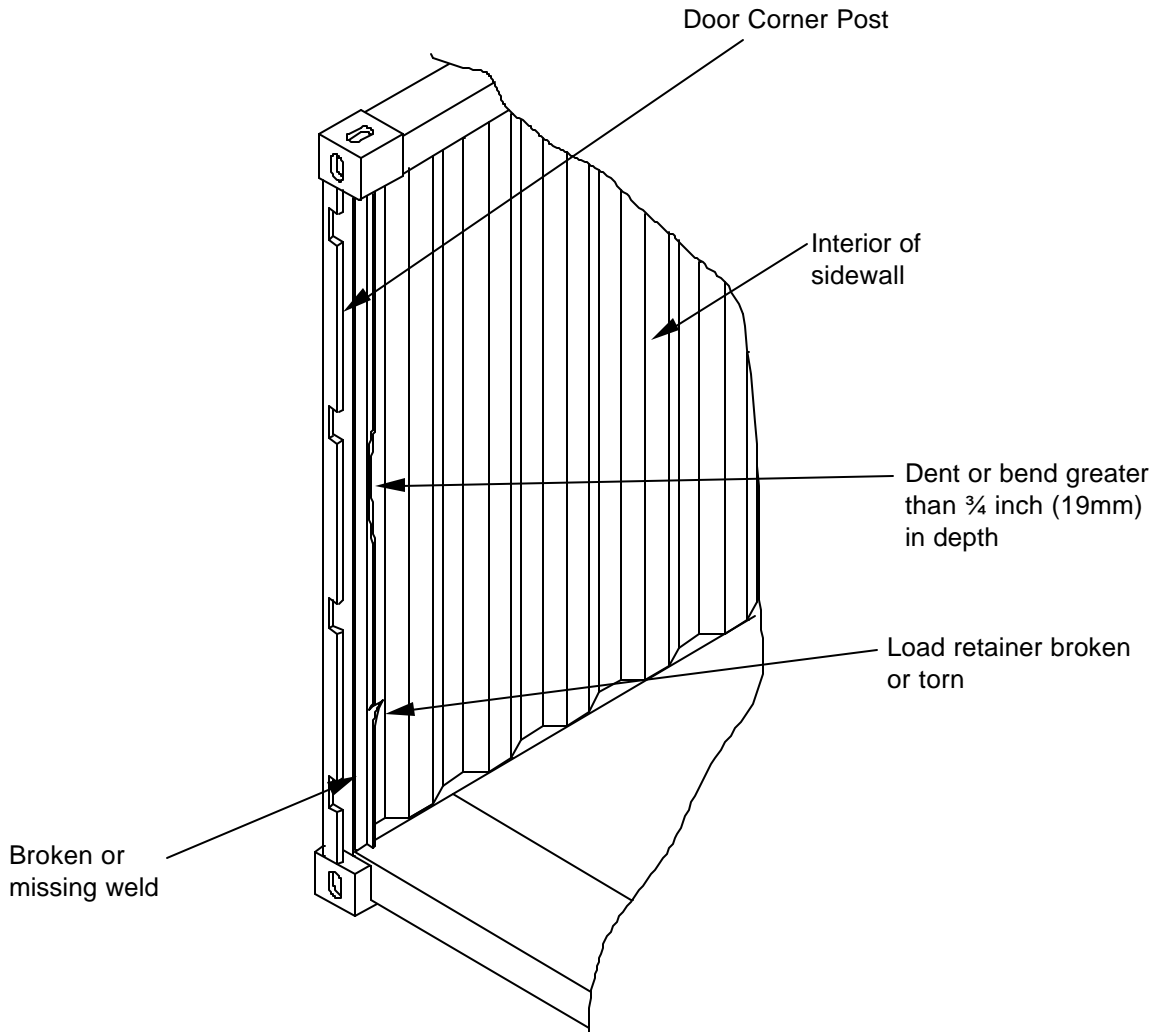
FIGURE 5.3.9B – LOAD RETAINER DAMAGE

c. Load Retainers. Special load retainers such as a structural angle welded to each door corner post of an end-opening container must be inspected to ensure serviceability. A missing, cracked, or broken weld at the juncture between the load retainer and the container structure is unacceptable. A dent or bend in the retainer that is greater than 3/4 inch (19mm) in depth, regardless of length, is also unacceptable. Load retainer must have no cracks, breaks, cuts, tears, punctures, or corrosive failures.

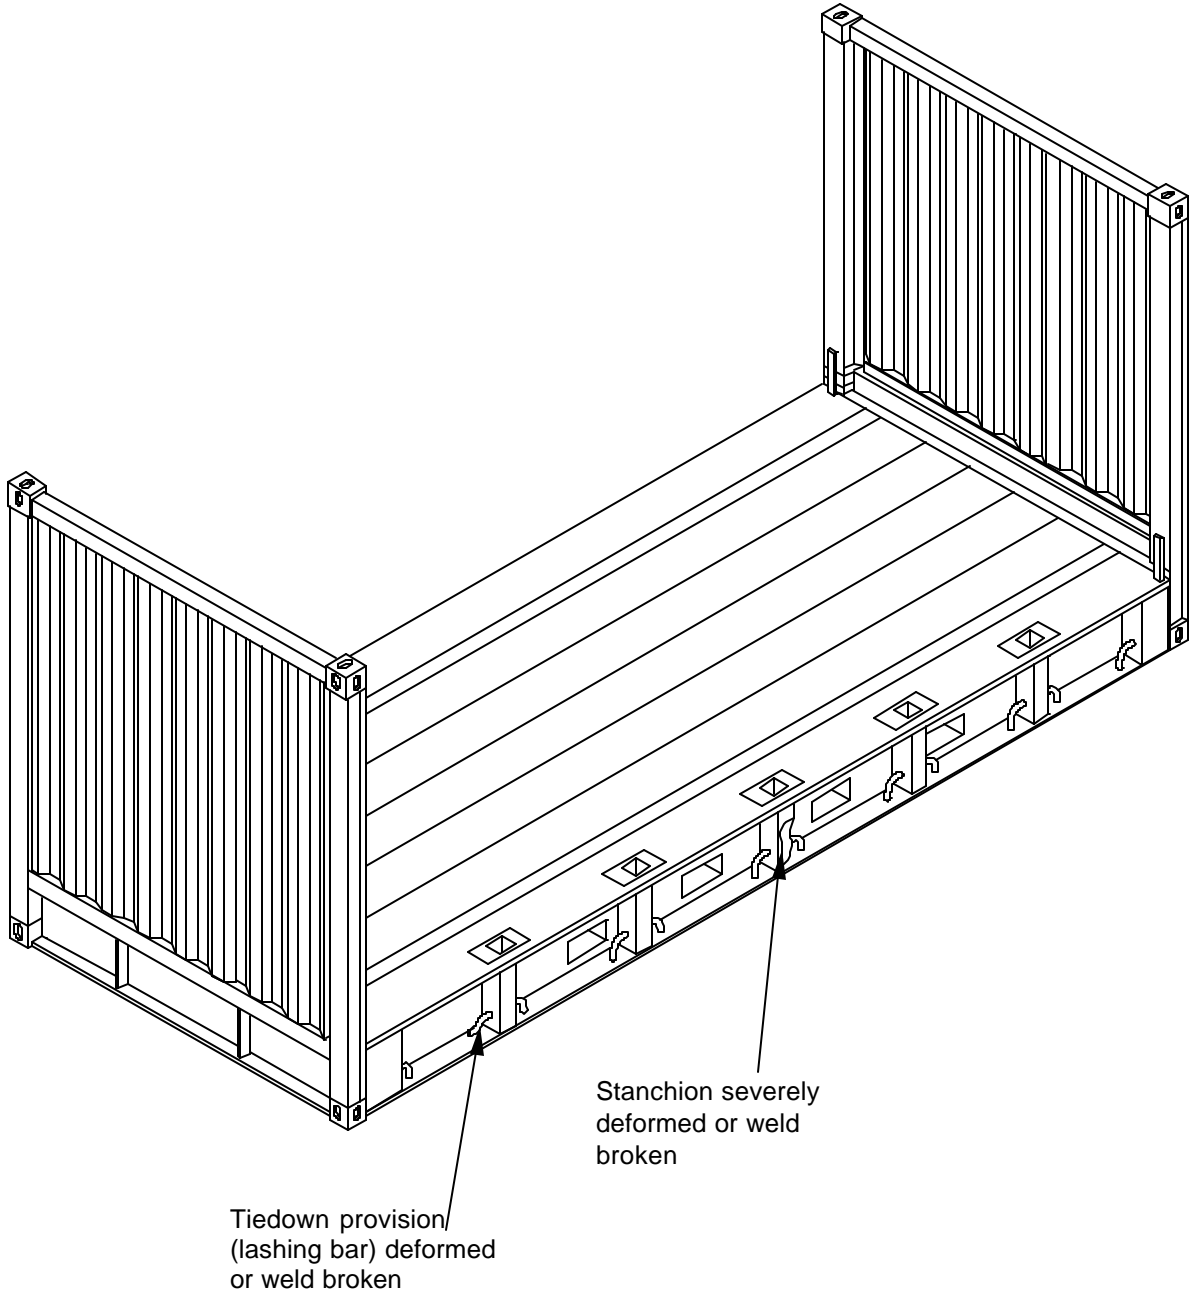
**FIGURE 5.3.9C – DAMAGED FLATRACK RESTRAINT PROVISIONS**

d. Tiedown Provisions (Lashing Bars or Rings). Provisions or fittings used for attachment of straps or other cargo restraint devices must be in working order. Tiedown provisions that are deformed or broken are not cause for rejection of the container as long as the damaged tiedown provisions are not required for securing the cargo and the structural integrity of the container is not otherwise impaired.

e. Stanchions. A missing, cracked, or broken weld at the juncture between a stanchion (stake pocket) and the flatrack structure is unacceptable. Severe deformation of a stanchion that would restrict installation of a stake is also cause for rejection.

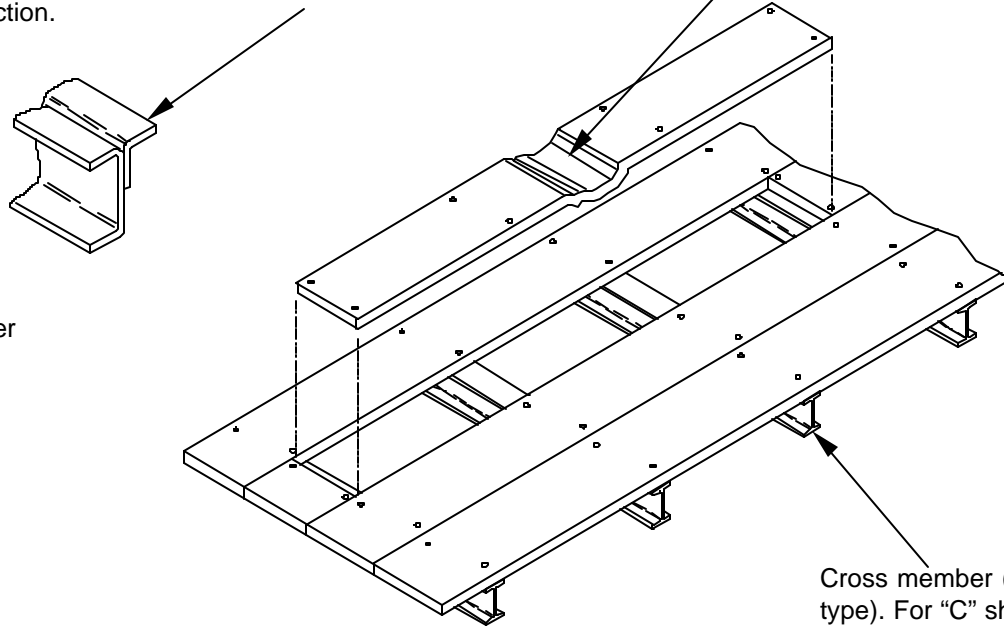
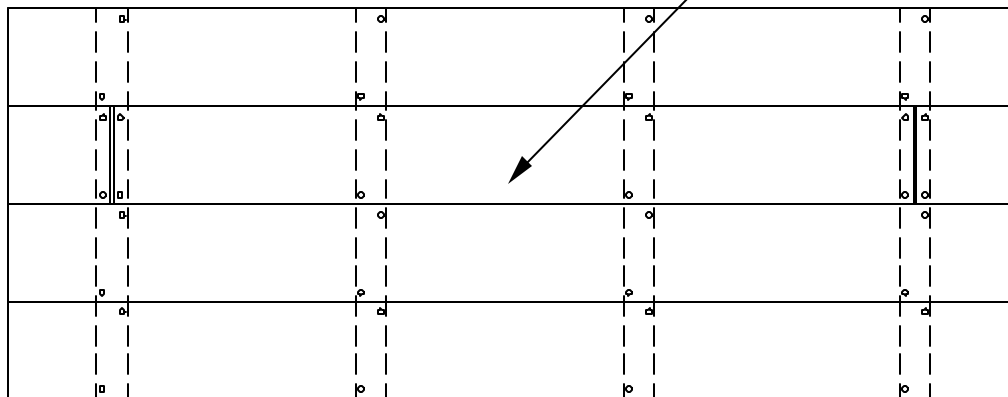
**FIGURE 5.3.11 – EXAMPLE OF FLOORING REPAIR**

Structural angle must be welded to narrow "C" shaped cross member under each end of replacement board section to provide an adequate surface for attachment. Angle must be sized to extend beyond and be attached to adjacent floor board on each side of repaired section.

Although damage may occur in a small area, the replacement board section must be sized to span at least four cross members

Cross member  
("C" shape)

Cross member (I-beam type). For "C" shape type see detail above

**REMOVAL OF DAMAGED BOARD**

Note: Only one partial length replacement board section per length of container is permitted and no more than three partial length replacement board sections throughout the entire container floor are permitted. Laterally adjacent repaired sections must not have joint resting on the same cross member.

Partial length replacement board section must span at least four cross members

**FINISHED REPAIR**

5.3.11 Acceptable Wooden Flooring Repairs. Refer to Figure 5.3.11. Only one partial length replacement board section per container length and no more than three partial length replacement board sections throughout the entire container floor are permissible. Partial length replacement board sections must span at least four cross members and be of similar material, similar size, and configuration as the rest of the flooring. Laterally adjacent repaired sections must not have joints on the same cross member. Both ends of each joint must be adequately supported by and securely fastened to the top surface of a cross member. If the top surface (flange) of the cross member is too narrow, such as a "C" shaped type cross member, a structural angle must be added to provide an adequate support surface. The added angle must be sized to extend beneath the adjacent floor board on each side of the repaired section.

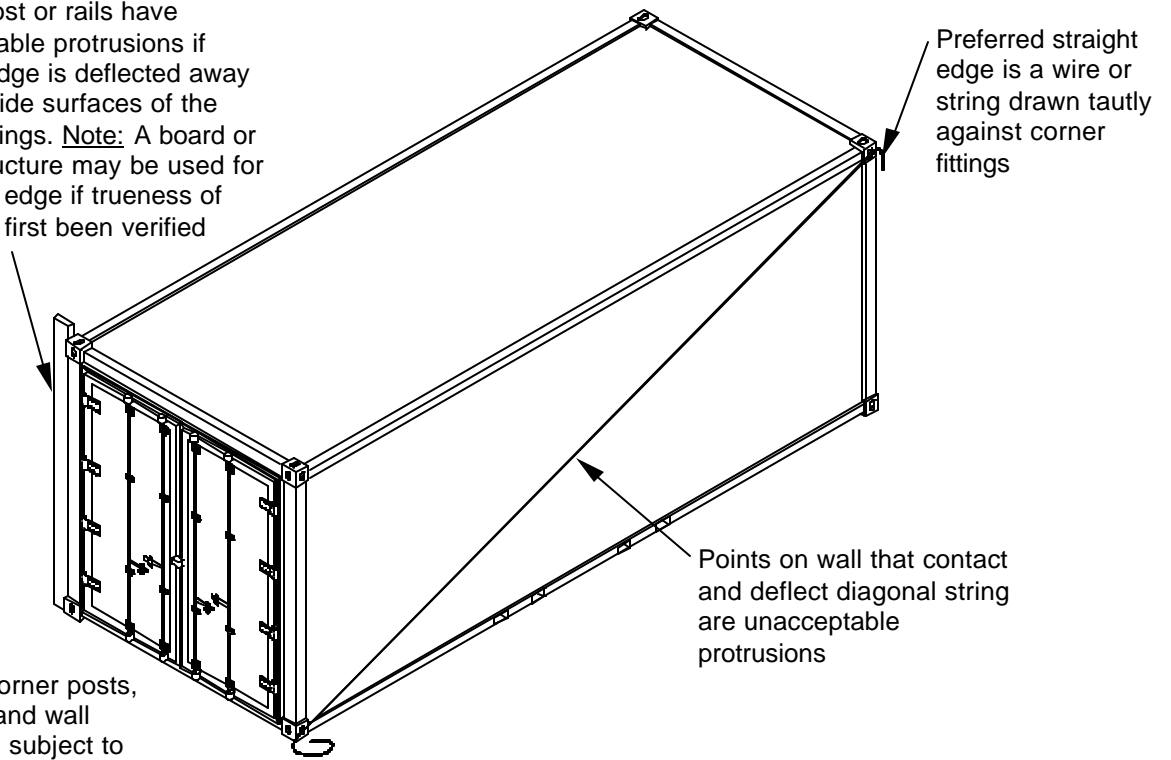
FIGURE 6.2C – CHECKING FOR PROTRUSIONS

Corner post or rails have unacceptable protrusions if straight edge is deflected away from outside surfaces of the corner fittings. Note: A board or metal structure may be used for a straight edge if trueness of edge has first been verified

Note: All corner posts, rails, roof and wall panels are subject to checking

6.2.1 Long Straight Edge. A tautly drawn wire, string, or other form of a long straight edge is needed to determine whether any portion of the container (e.g., a panel or a rail) protrudes past the outside surfaces of the corner fittings. Refer to Figure 6.2.C for typical methods of checking for protrusions.

6.3.2 Overall Configuration. Check for any distortion of the overall configuration great enough to preclude proper engagement of handling/lifting equipment, mounting and securing on chassis or vehicle, or insertion into the cell of a ship. If container alignment is in question, use a measuring tape to check dimensional tolerances in accordance with Figure 5.1. Using a suitable straight edge, check for any protrusions beyond the outside surfaces of the corner fittings. Refer to Figure 6.2C.

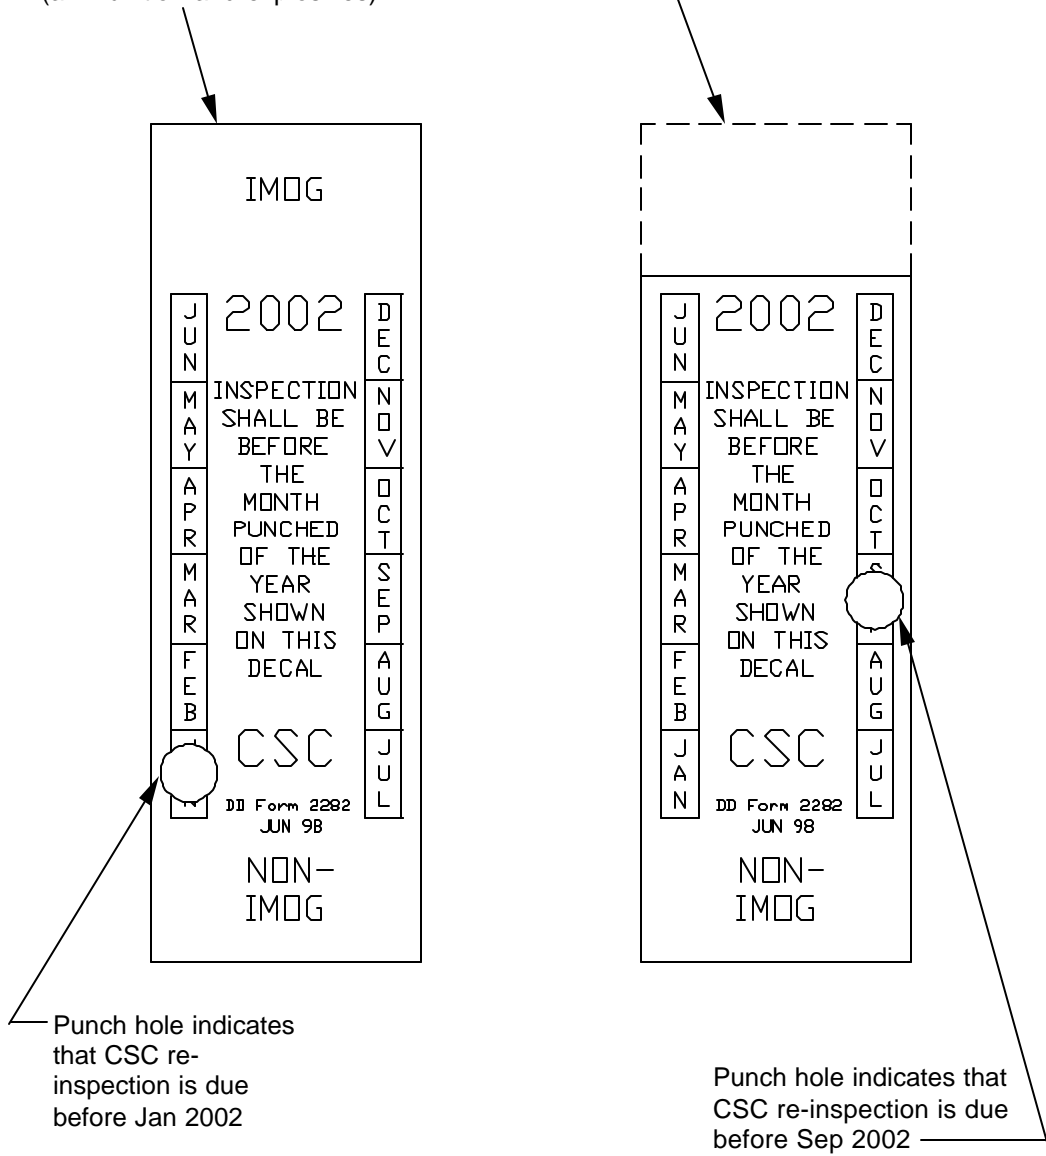
FIGURE 6.4 – DD FORM 2282 DECAL

Decal with top "IMDG" portion remaining indicates container is serviceable for shipment of all items including UN Hazard Class 1 (IMDG) items (ammunition and explosives).

Decal with top "IMDG" portion removed (or cut off) indicates container is only serviceable for shipment of general cargoes and cannot be used for UN Hazard Class 1 (IMDG) items.

- c. Serviceable for General Cargo. Containers not meeting serviceability requirements prescribed for the shipment of UN Hazard Class 1 (IMDG) explosive materials, but still complying with basic criteria for shelters and general cargoes, will be marked with DD Form 2282 decal displaying only "NON-IMDG" portion of the decal. Refer to Figure 6.4. Marking a container in this manner indicates container is only acceptable for shipment of general cargoes and cannot be used for UN Hazard Class 1 (IMDG) (explosive) items.

- d. Serviceable for UN Hazard Class 1 (IMDG). Containers complying with basic criteria for general cargoes and meeting all the serviceability requirements prescribed for the shipment of UN Hazard Class 1 (IMDG)(explosive) materials, will be marked with a DD Form 2282 decal displaying both "IMDG" portion and "NON-IMDG" portion of the decal. Refer to Figure 6.4. Marking a container in this manner indicates container is acceptable for shipment of all items including ammunition and explosives.
